A REPORT ON THE 1992-1993 EXCAVATIONS:
THE PERIMETER OF THE HOUSE
AND EXCAVATIONS RELATED TO RESTORATION
DRAINAGE/FOUNDATION WORK
AT
POPLAR FOREST, FOREST, VIRGINIA

Barbara J. Heath, Director of Archaeology

1993

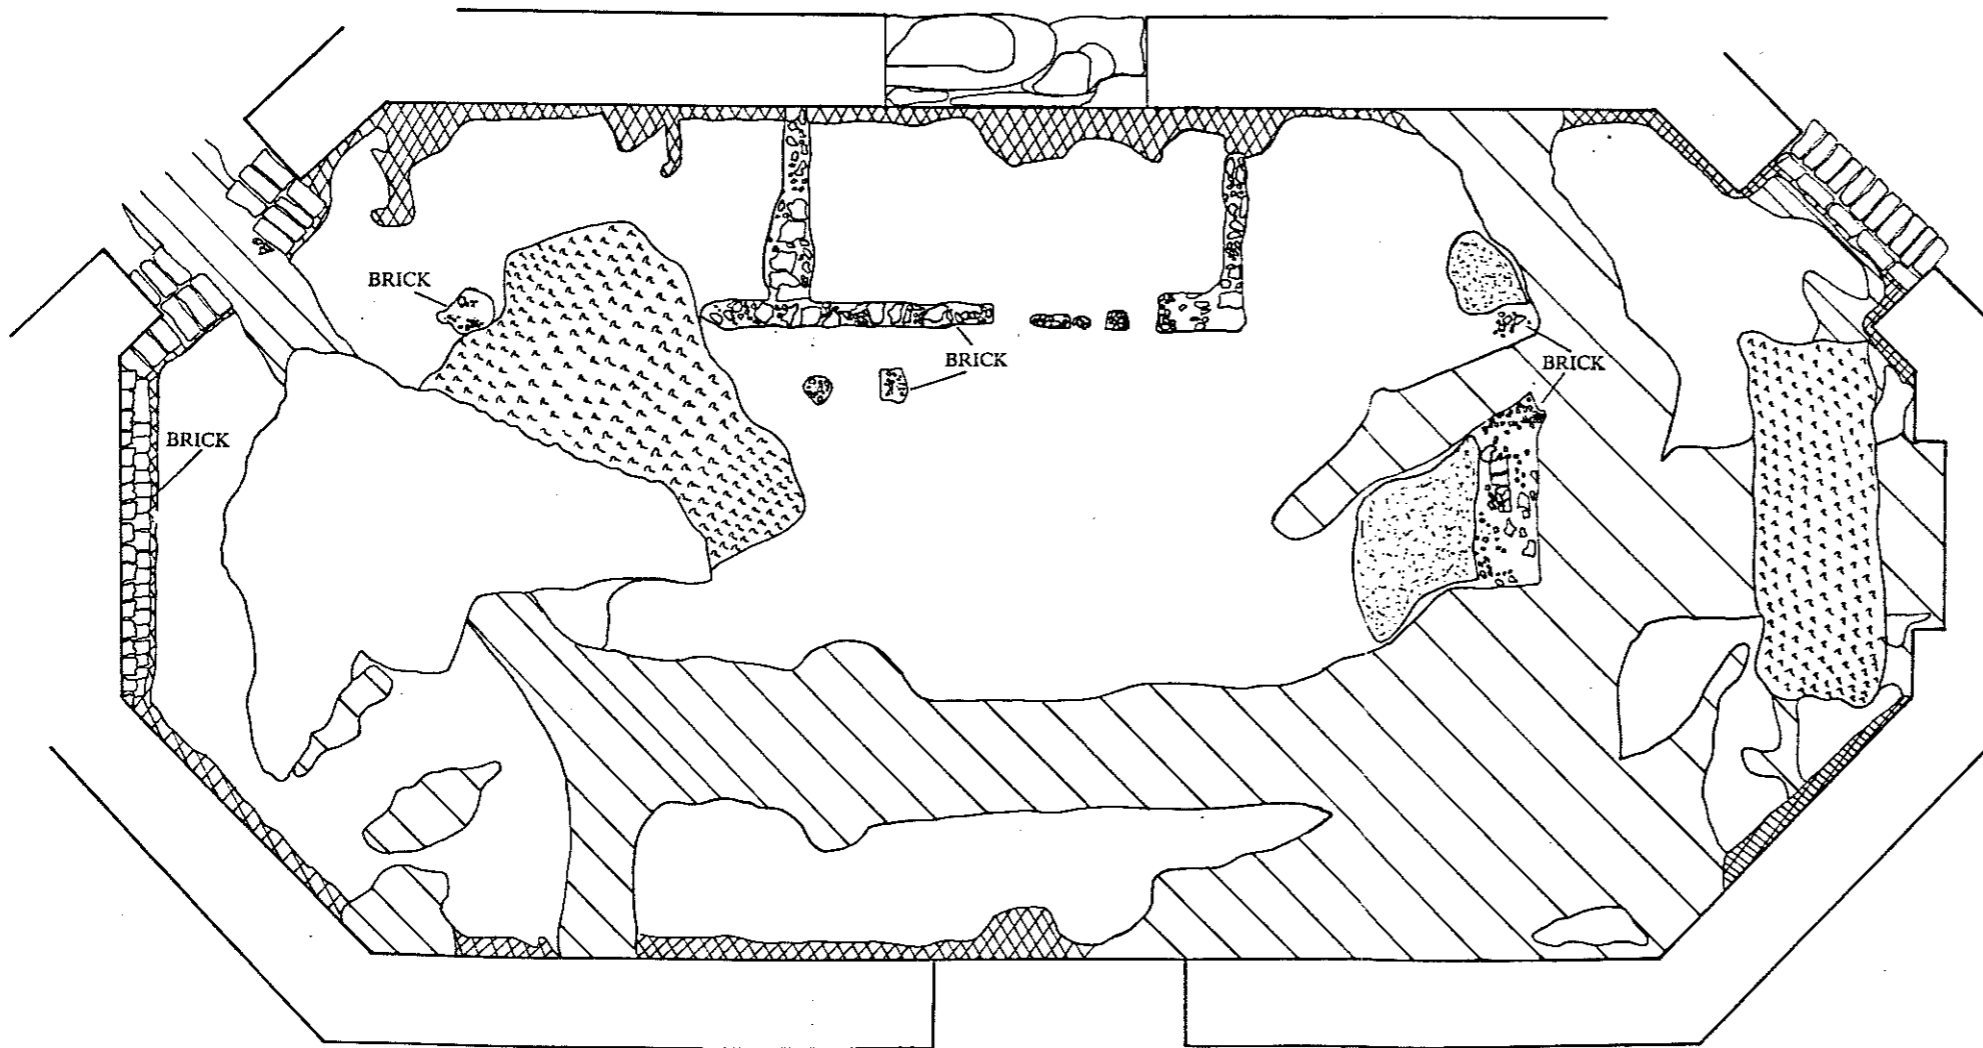
FIGURE 4
 EXCAVATED FEATURES NORTH ROOM
 MAIN HOUSE

An unexpected, and as yet unexplained, find was located parallel to the west wall of the room. There, a rectangularly shaped feature measuring approximately 1.5' x 5' intruded subsoil to a depth of 0.7'. The feature had straight sides and a flat bottom, and was filled with mixed red and brown loam. Within the fill were deposited a number of domestic objects, including two clay marbles, a handle of a large hollowware vessel decorated with a flow blue decoration, a

Four units were excavated in the north room; ER643 and 644 along the western quarter of the room, ER606 beneath a Watts era closet, and 645, which encompassed the remainder of the floor area (Figure 3). Beneath the concrete and gravel layer, a thin layer of loose brown loam with brick and mortar fragments extended across the room. The layer contained a scattering of artifacts dating from the late nineteenth century into the early twentieth century, including ironstone and flow blue earthenware sherds, cut and wire nails, a paper clip, and a few fragments of glass. The removal of the cement and gravel also revealed surviving brickwork bonded into one wall of the room, and free standing brick remains located beneath a Watts era closet and bathroom wall dating to 1947 (Figure 4).

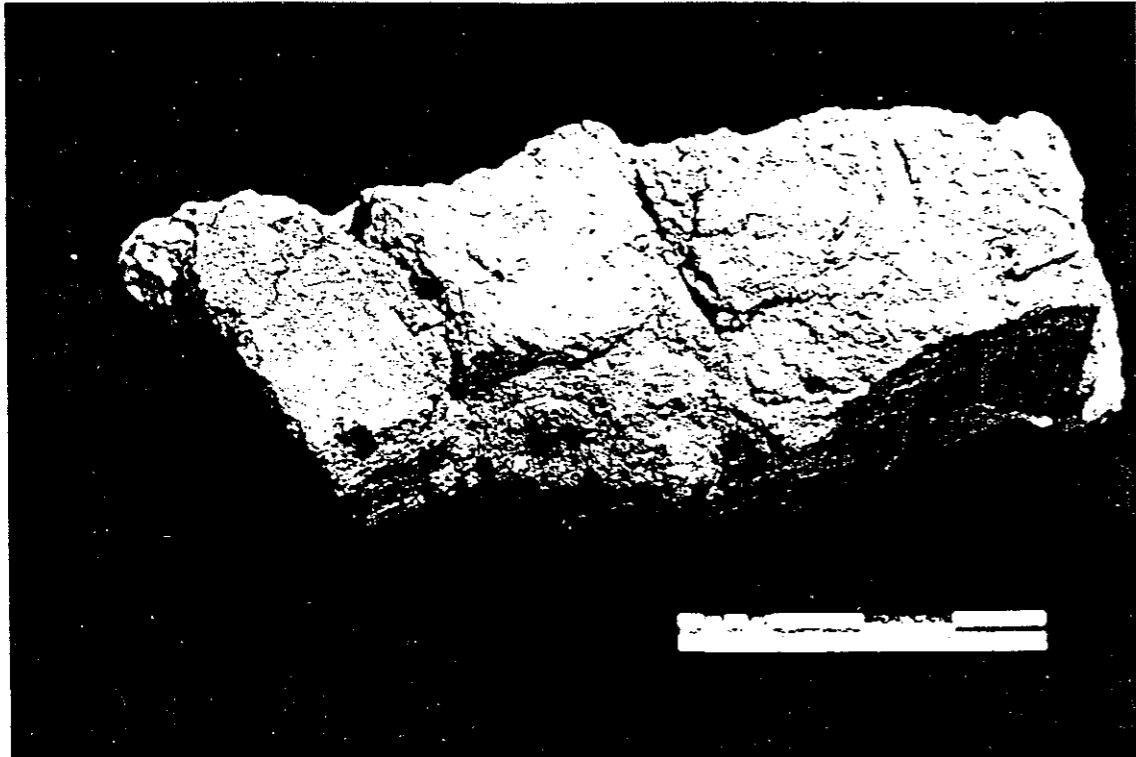
FIGURE 6

"Stratified" brick flooring fragment, with oldest surface containing vessel glass on the top, and latest surface, coated with concrete, on the bottom.

A portion of "stratified" flooring was recovered from the fill of one of the 1947 pipe trenches, providing clear evidence of the post-Jefferson history of the room (Figure 6). Several fragments of brick, contemporaneous with the bricks uncovered beneath the partition wall, were sealed by a thin layer of concrete. This concrete predates the Watts floor. Stuck to the bottom of the bricks is a fragment of vessel glass, indicating an occupation surface, of unknown material, existed in the room prior to the laying of the brickwork.

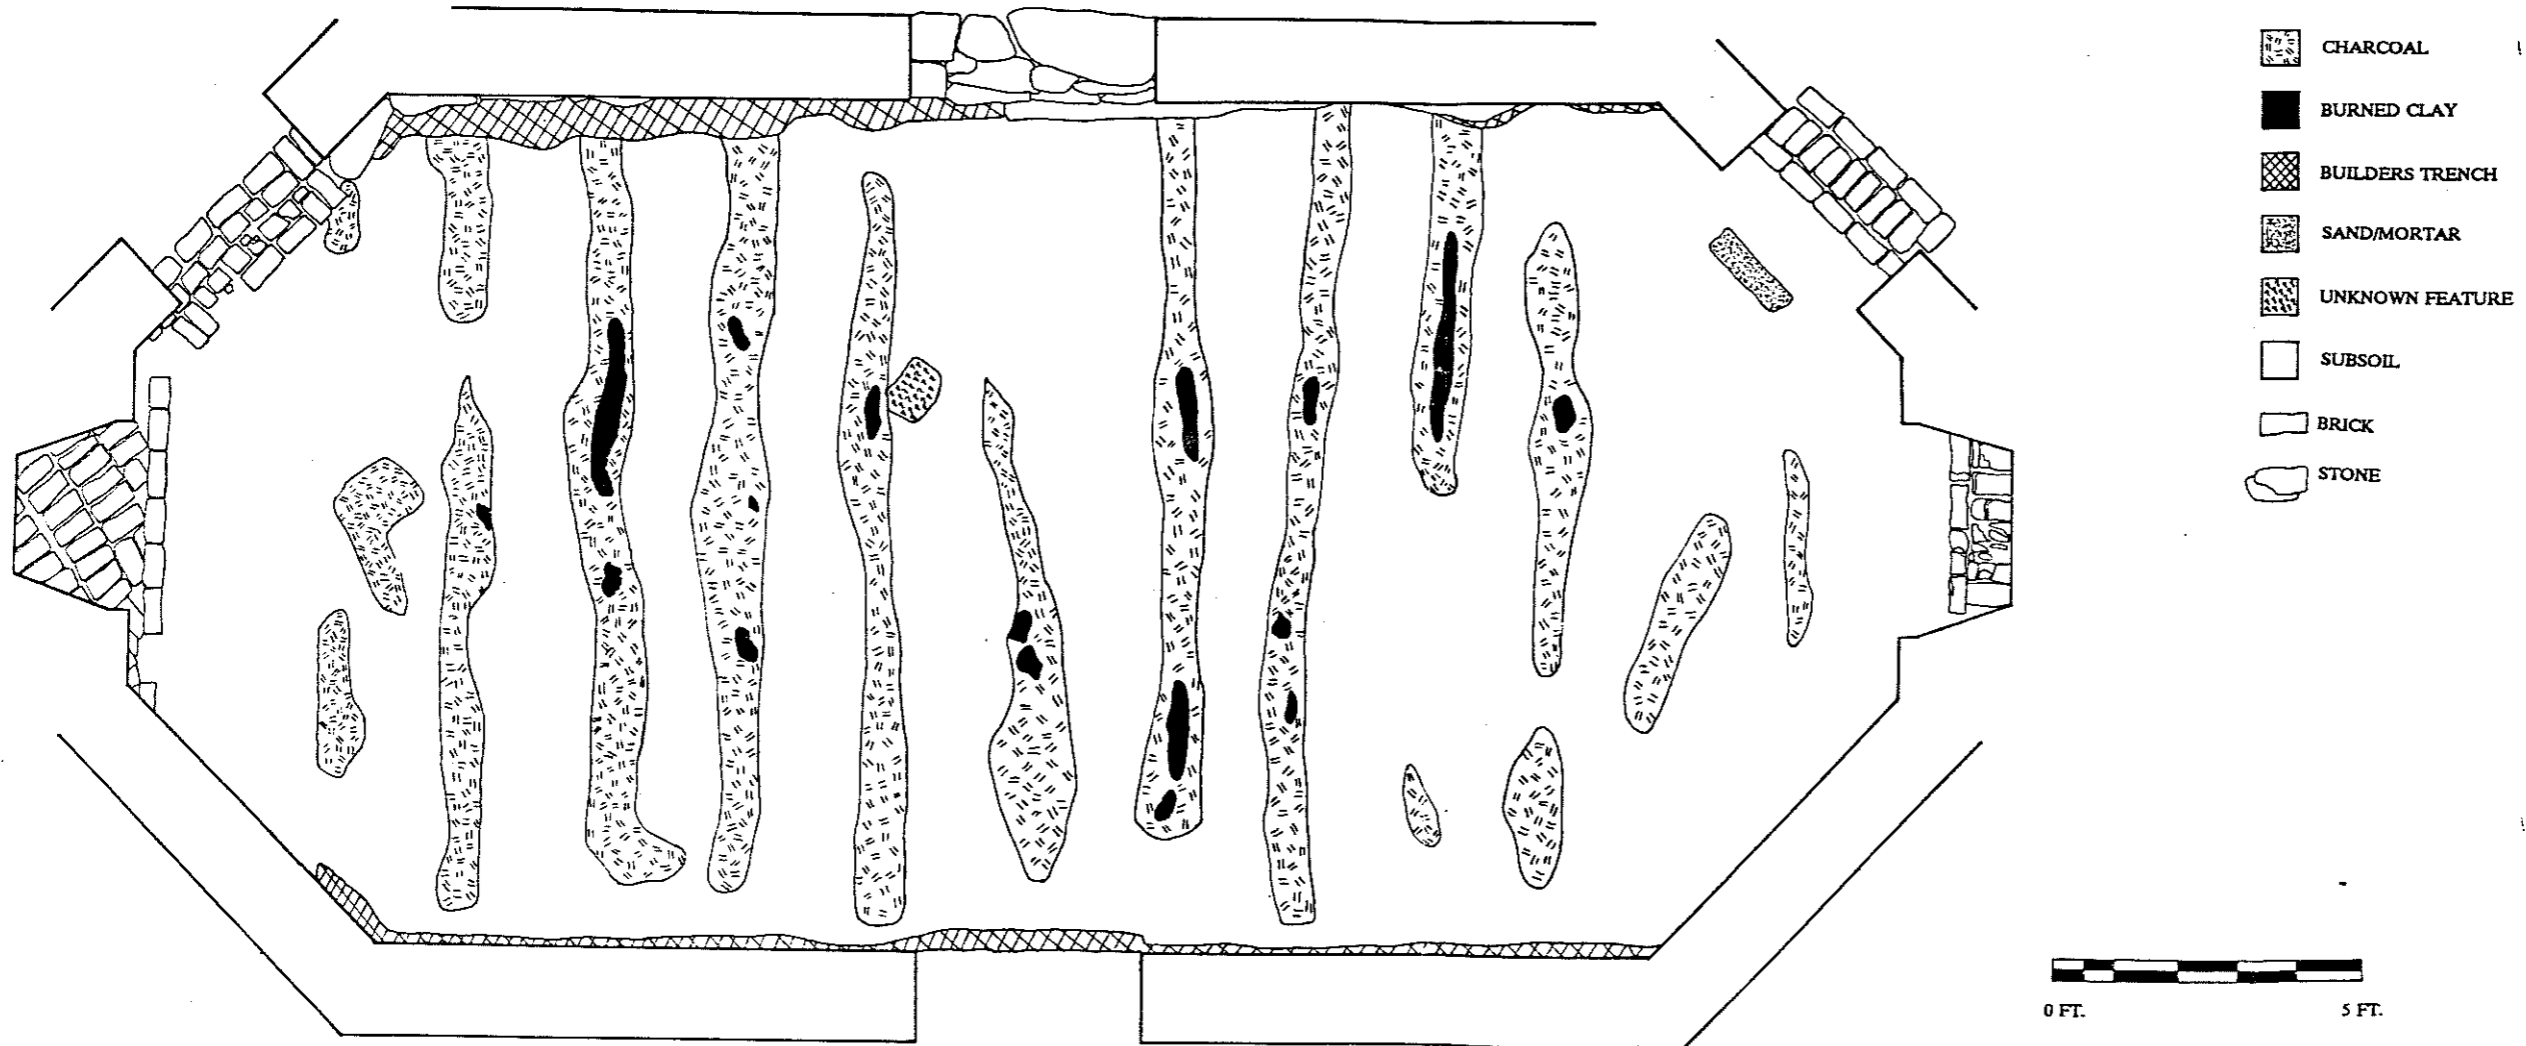
FIGURE 7
EXCAVATED FEATURES SOUTH ROOM
MAIN HOUSE

charcoal surrounded by clay burned to the consistency of brick. The most intact burn scars were located in the center of the room, and ran from the north wall to within 0.3' of the south wall (Figures 7 and 8). Aligned on two foot centers, the joist scars spanned the room, becoming more disjointed and disturbed in front of the east and west hearths.

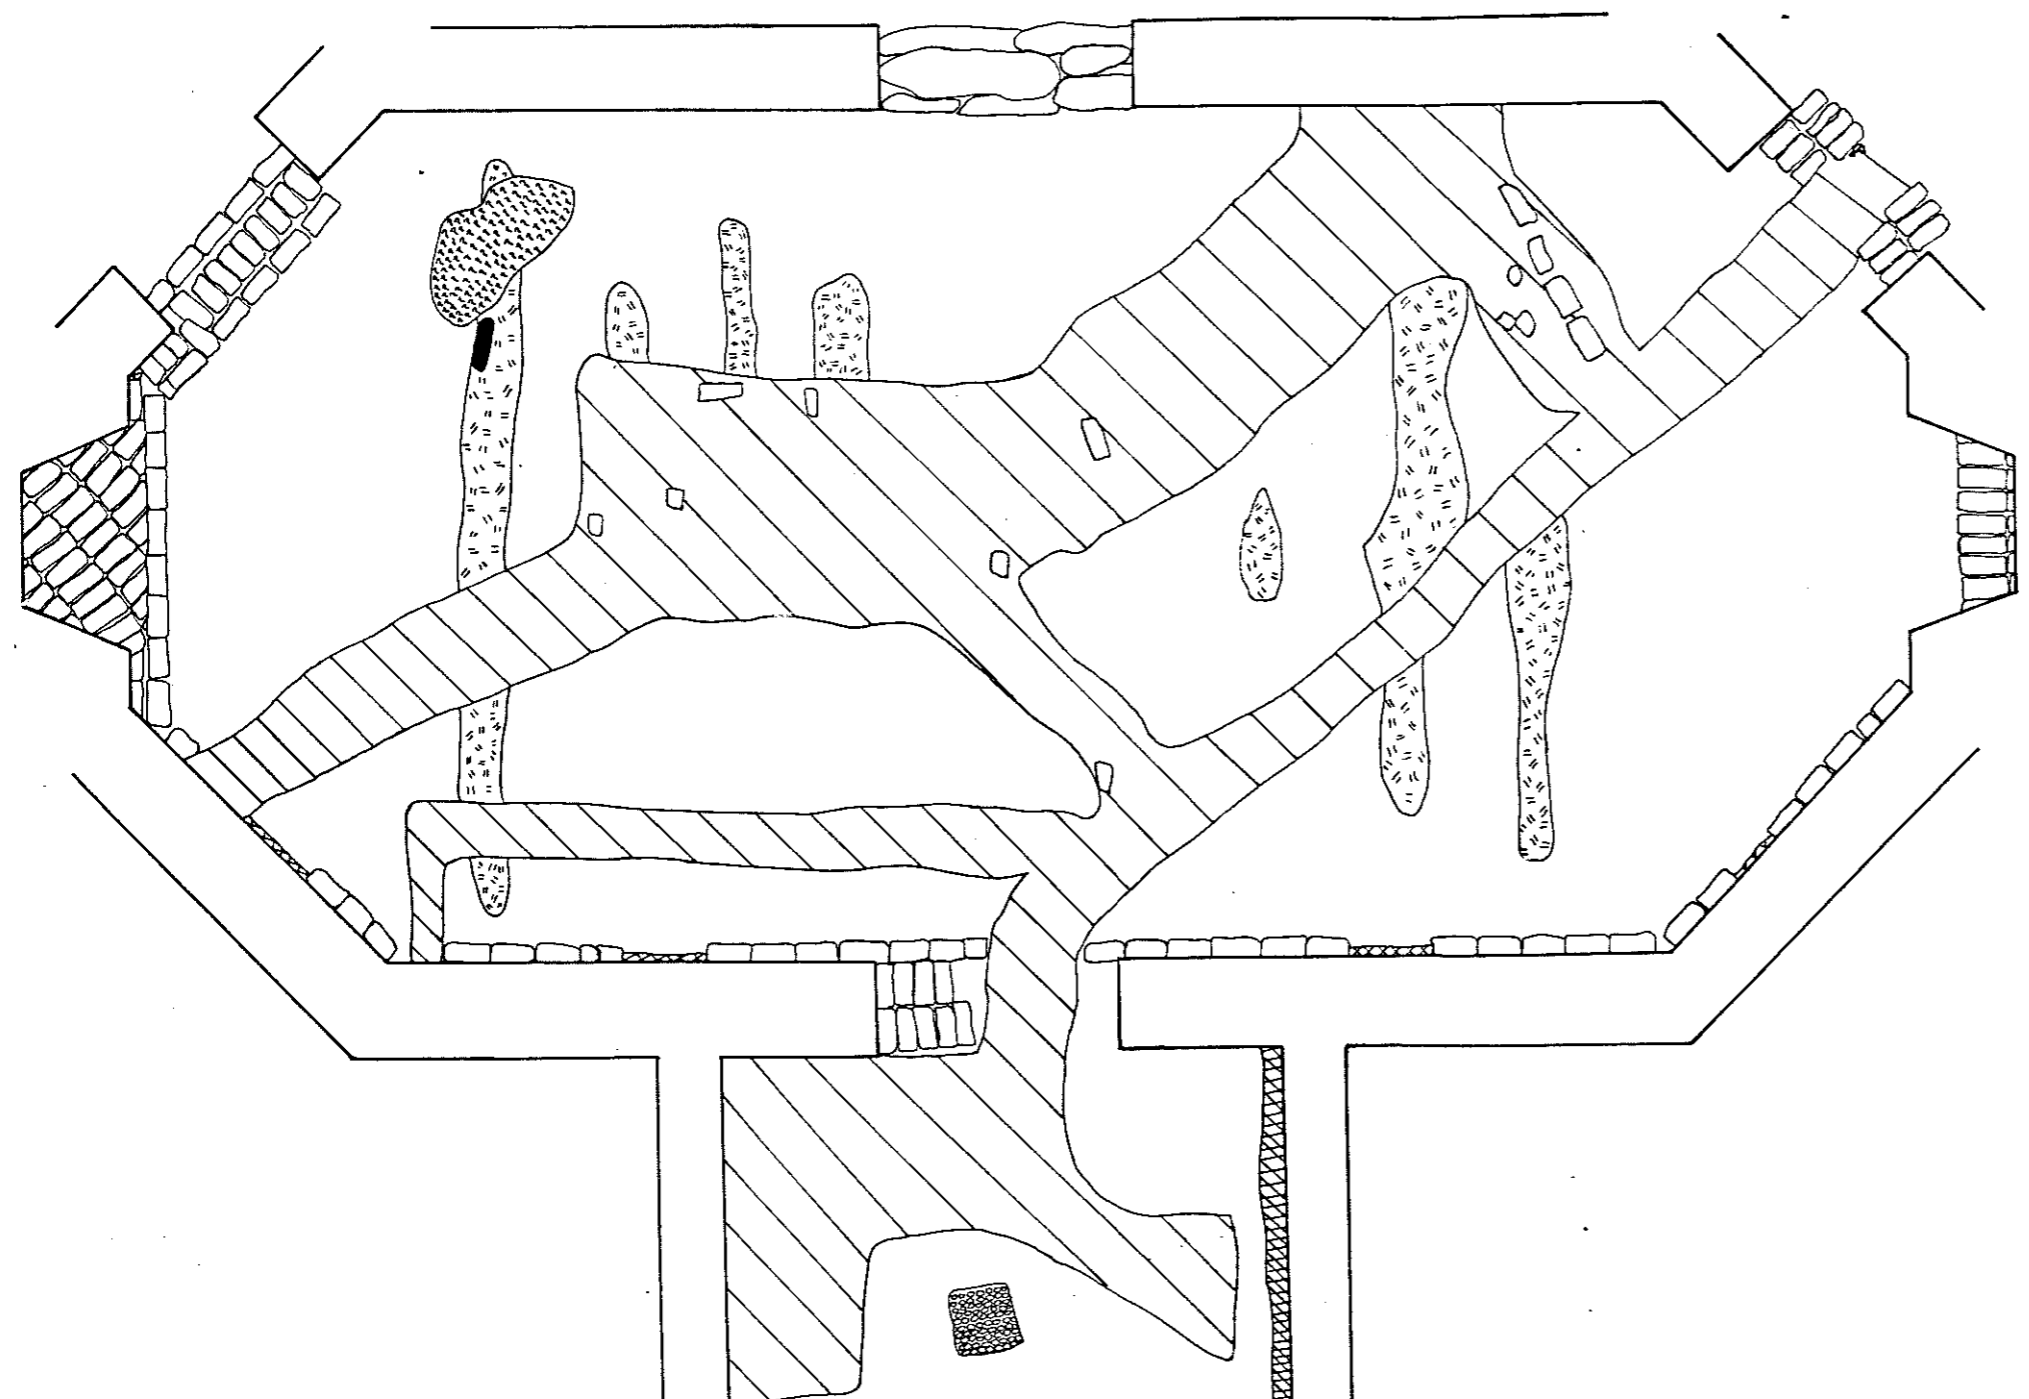
FIGURE 9
 EXCAVATED FEATURES EAST ROOM
 MAIN HOUSE

Like the south room, the east room contained the scars of burned floor joists spaced on two foot centers. No joists were discovered in line with the doorway to the east stair pavilion. While the center of the room was extensively disturbed by pipe trenches, enough undisturbed soil remained intact to have preserved joist scars had they been formed during the fire. This lack of evidence may point to an internal partition wall which, prior to 1845, divided the east

Beginning east of the south hearth and running along the southeast and east walls of the room stretched a line of bricks. The bricks measured 8" x 3 9/16" x 2 13/16" in dimension. Archaeologists removed four of them, and discovered that they were not mortared to each other or to the face of the wall. Mortar traces on the surfaces of several of the bricks, however, suggested that originally there was at least one additional brick course associated with this feature. Burn stains on the east wall stop at the top of this missing course of brick, indicating that in 1845, this feature existed to a height of two courses above modern subsoil.

the pavilions had been added to the house after the exterior walls were erected, they would contain within them preserved sections of the original builder's trench which had escaped exterior waterproofing. While a narrow section of builder's trench was found against the west wall of the east pavilion, part of it had been disturbed in the late nineteenth century (Figure 9).

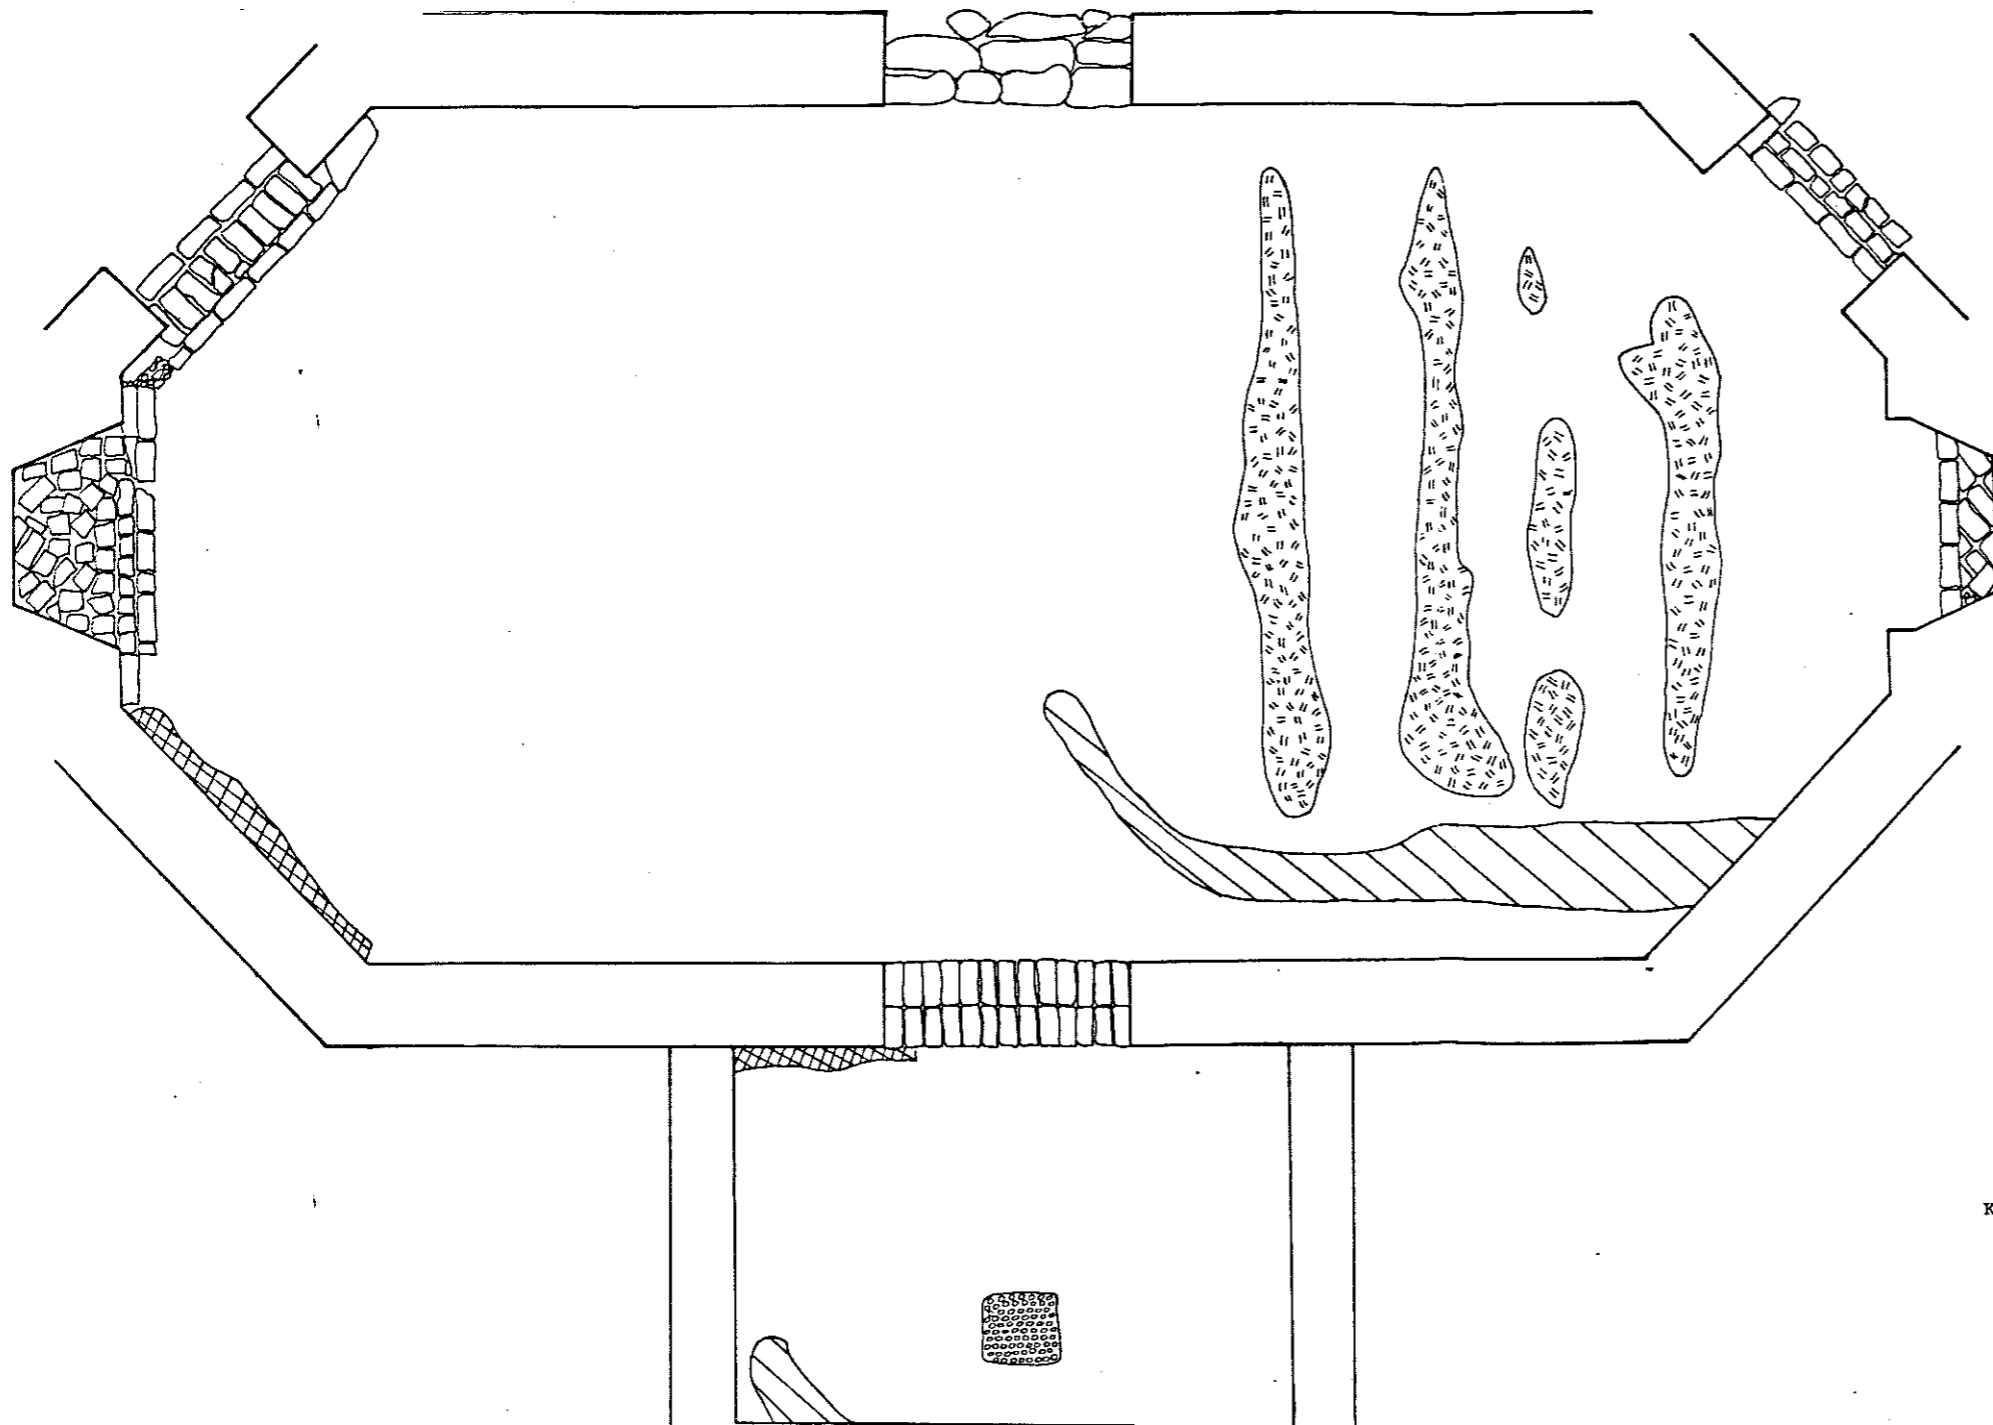
FIGURE 10
EXCAVATED FEATURES WEST ROOM
MAIN HOUSE

Archaeologists excavated five units in the west room. Each contained the layer of loose brown loam dating to the late nineteenth and early twentieth centuries found throughout the basement. Numerous rodent burrows and pipe trenches disturbed the soil around the north hearth and the southwest corner of the room. Still, clear evidence of four burn scars was uncovered in the south half of the room (Figure 10). No burn scars were observed in the north half, suggesting the possibility that the room was partitioned and floored with two different materials at the time of the 1845 fire.

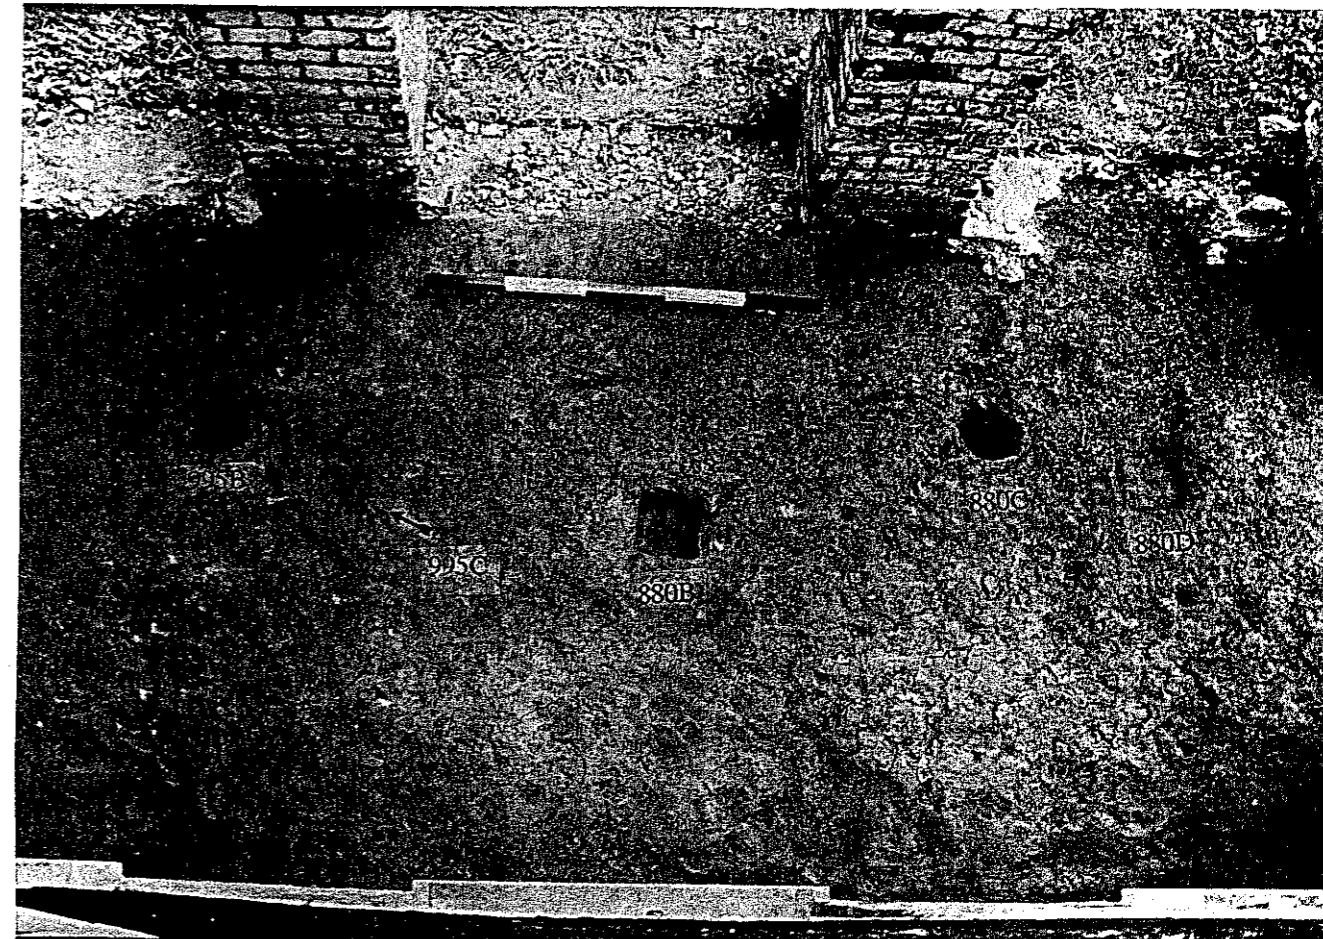
FIGURE 11

Scaffold holes beneath the south portico. ER 995C is indicated by arrow.

These modern deposits sealed five historic features, ER880B, 880C, 880D, 995B and 995C, and subsoil⁵ (Figure 11). ER880B was filled with loose red brown loam, ER880C contained brown loam with small amounts of charcoal, ER880D, 995B and 995C were filled with red brown loam, some charcoal, and the remains of decayed mortar (Table 1).

All of these features appear to be the subsurface remains of scaffolding. Historically, they are most likely to have been associated with either the initial construction of the

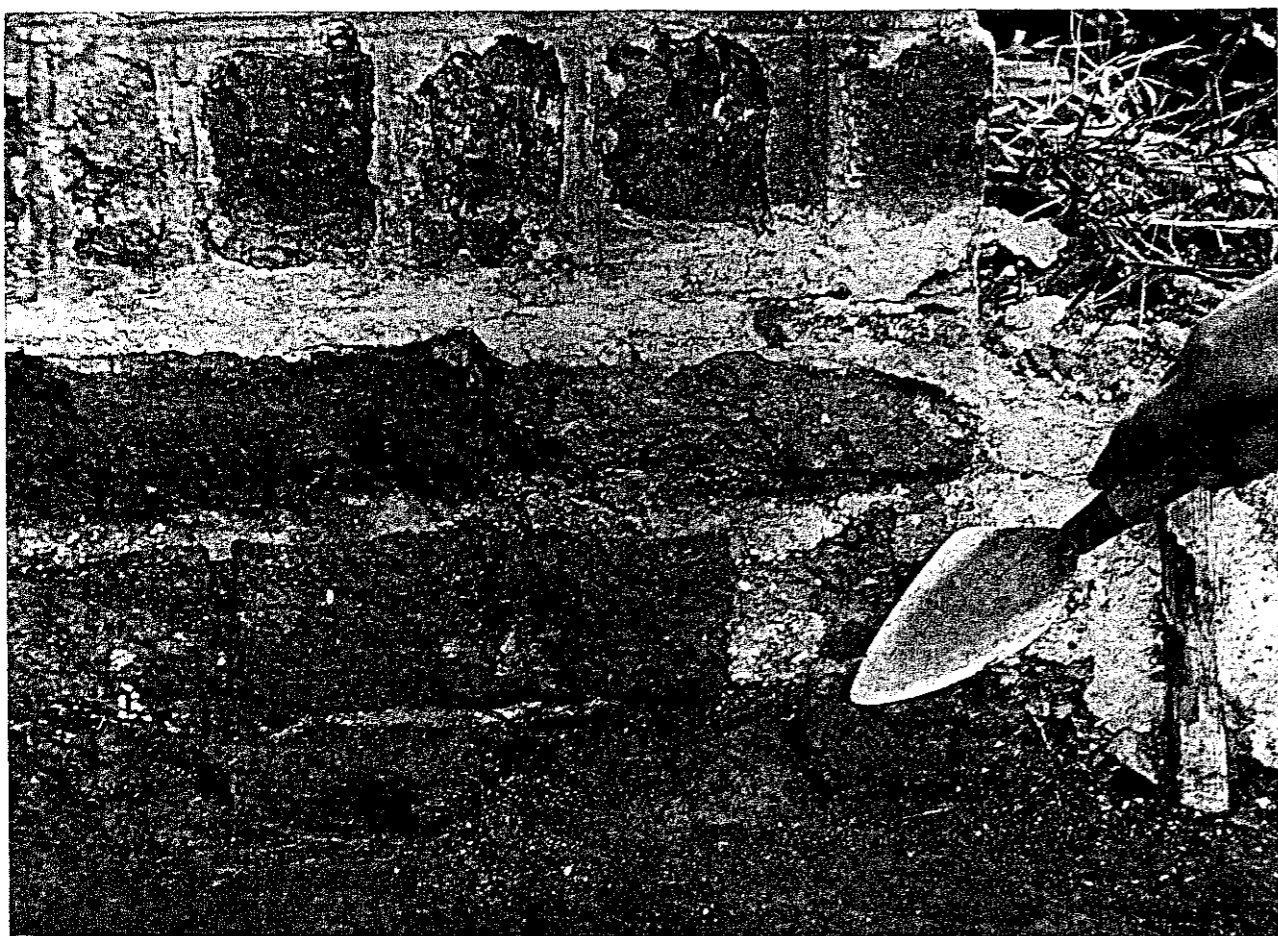
FIGURE 13

Trowel points to broken brick course at base of pier in South Portico.

A closer look at the elevation of the top of the broken bricks proves, however, that they cannot represent flooring. The top of the brickwork is less than a brick's width higher than the subsoil surface adjoining features 880B and 995C⁶. It is therefore impossible that these bricks could represent a reasonably level floor surface. Instead, they may be the

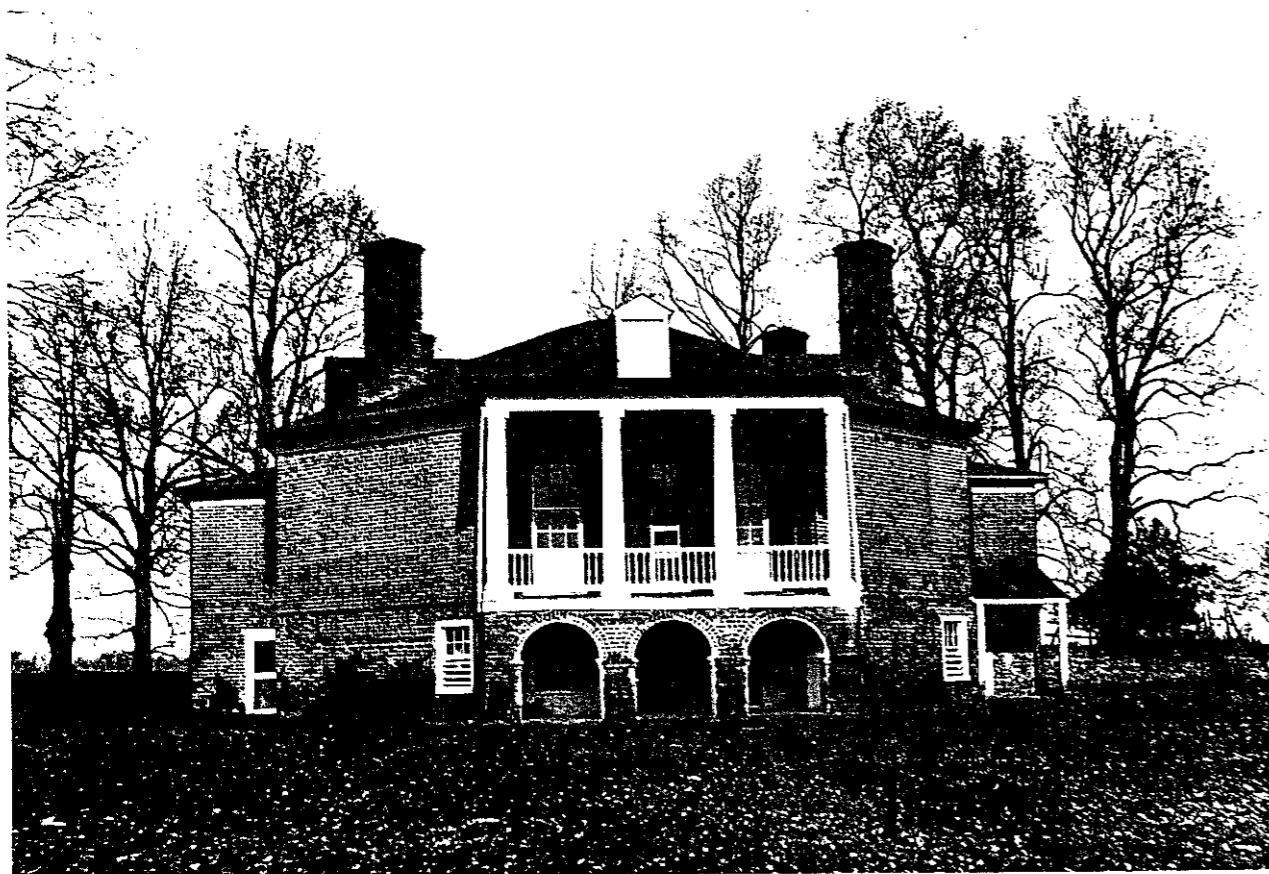
FIGURE 14

Early twentieth century view of south facade of Poplar Forest house showing hardpacked floor beneath the South Portico.

An additional discovery was made during excavations of the portico. Approximately 0.6' below the concrete line for the Watts era paving, a number of broken bricks, labelled 995D, were found extending out from the base of the northeast pier (Figure 13). Initially it was believed that these bricks represented the remains of an original paving. There is no historic evidence for flooring in this area during the Jefferson era; indeed the first surviving evidence for flooring appears in early twentieth century photos. These show some sort of hardpacked surface beneath the portico, although none are sufficiently clear to allow for a close assessment of the flooring material (Figure 14).

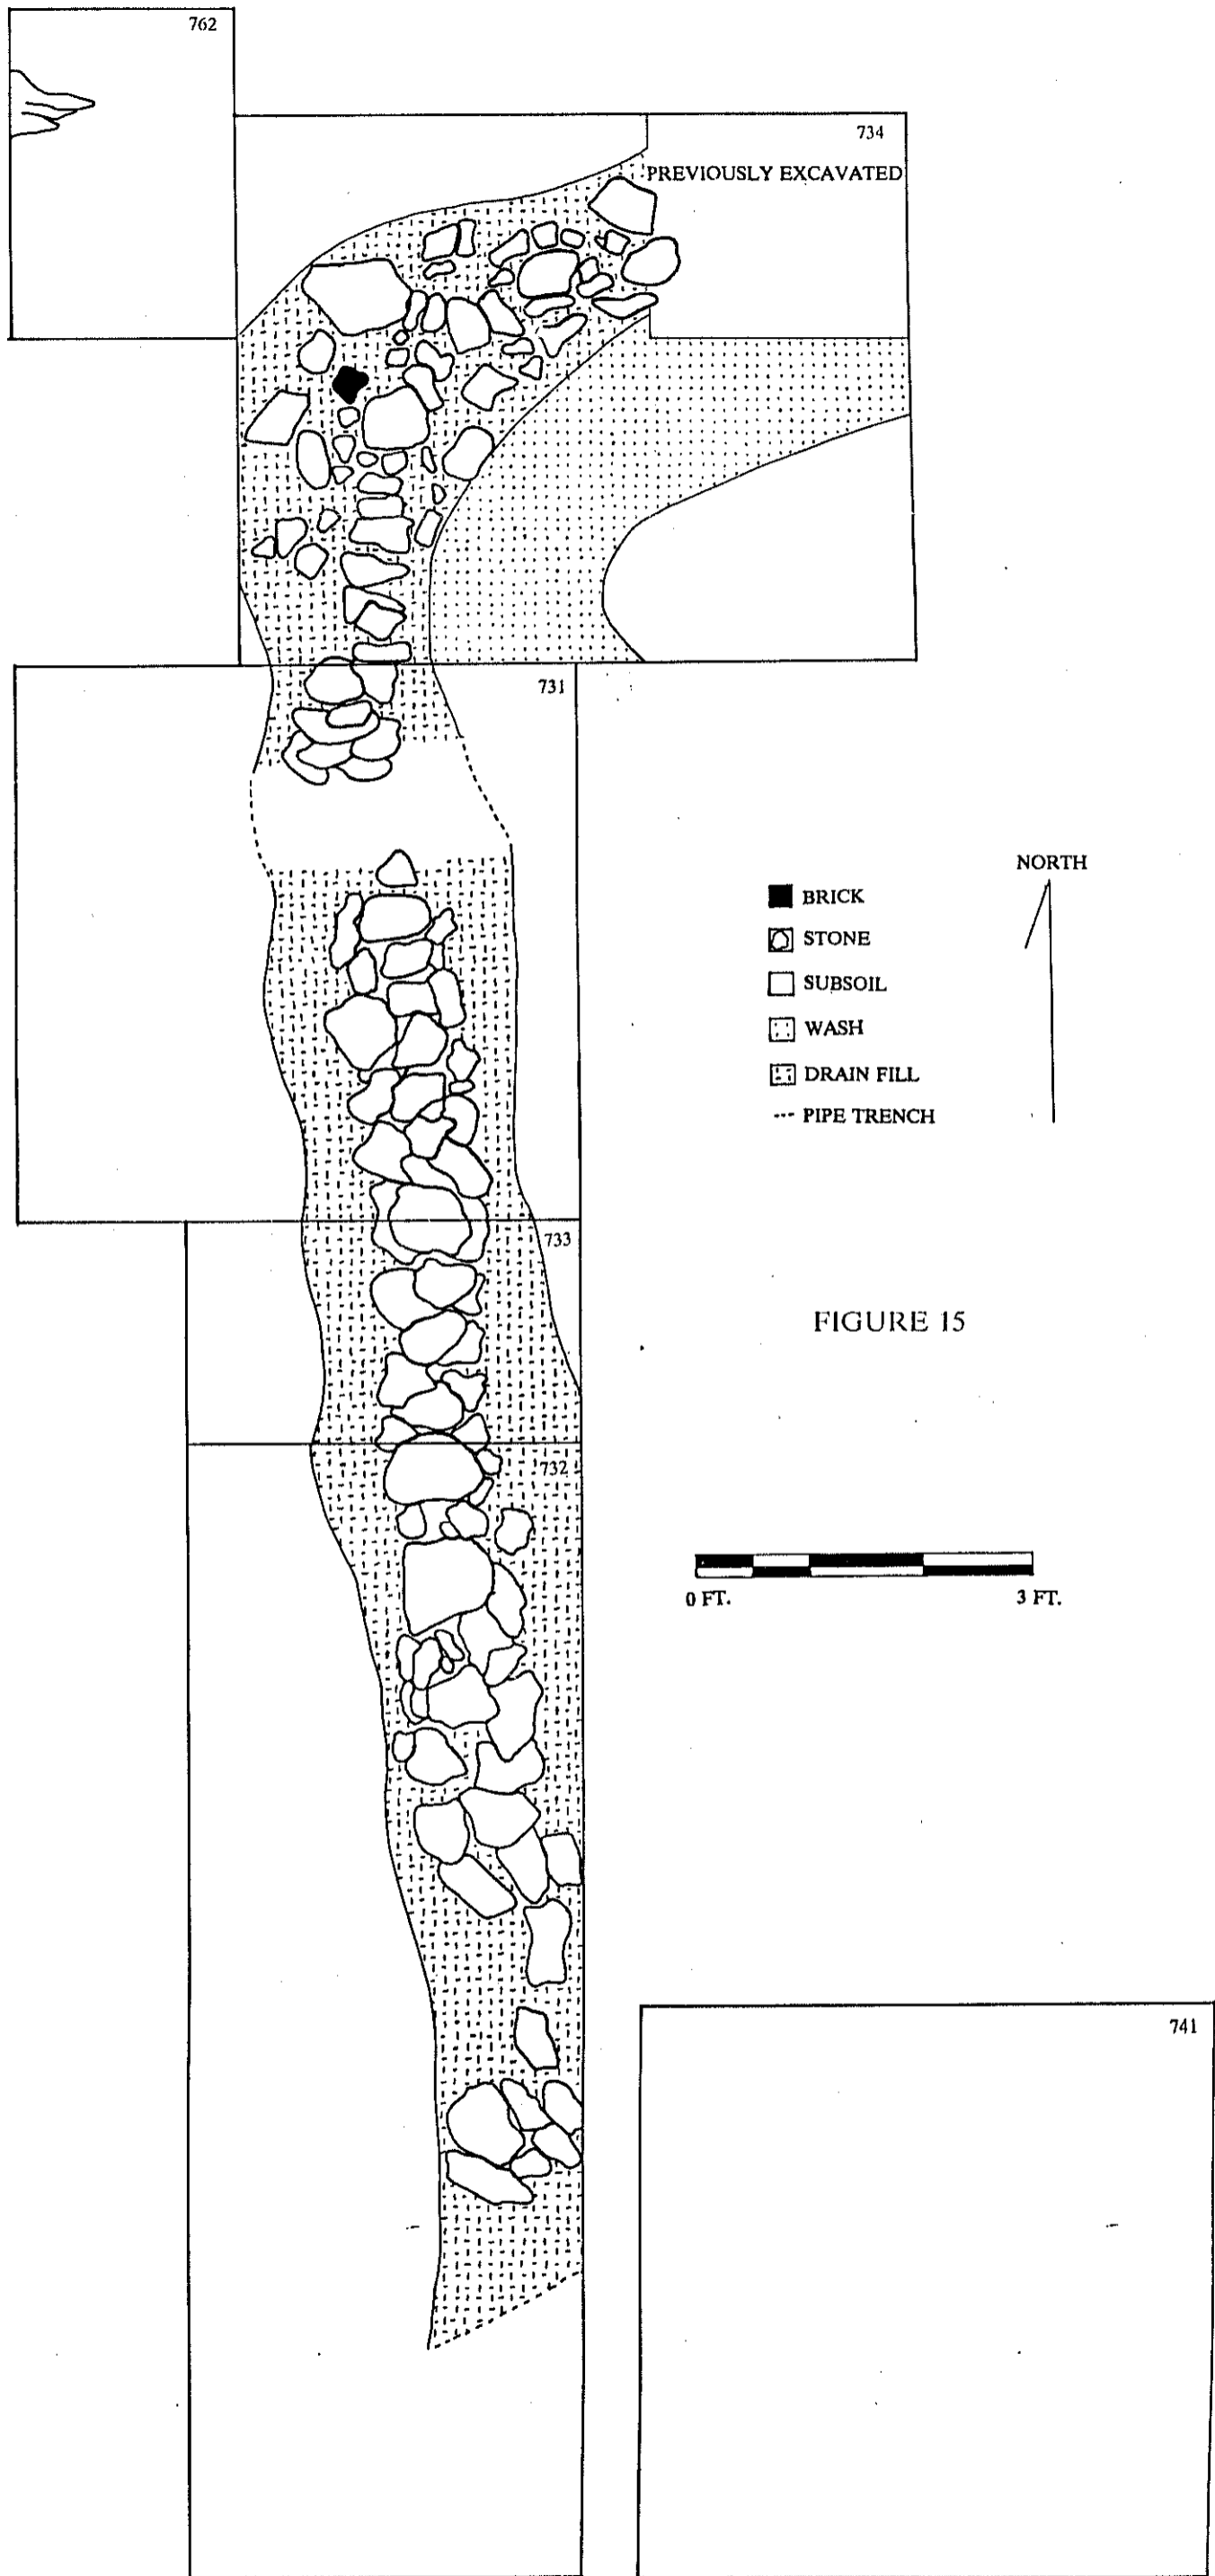
FIGURE 15

EXCAVATED FEATURES SOUTH YARD
FRENCH DRAIN

The drain appears to have been constructed by digging a shallow trench and filling the center with cobbles ranging in size from approximately 0.4' - 0.8' (Figure 15). This was accomplished with evident attention to detail. Stones were neatly arranged within the trench, and additional stones were

laid lengthwise on top to form a cap. Rich organic soil, containing a range of domestic objects, filled the voids between the stones, and in some areas, sealed the capstones. Artifacts recovered within the drain fill have been used to confirm the date of its construction, most probably 1814-1815 when the wing of offices was completed.

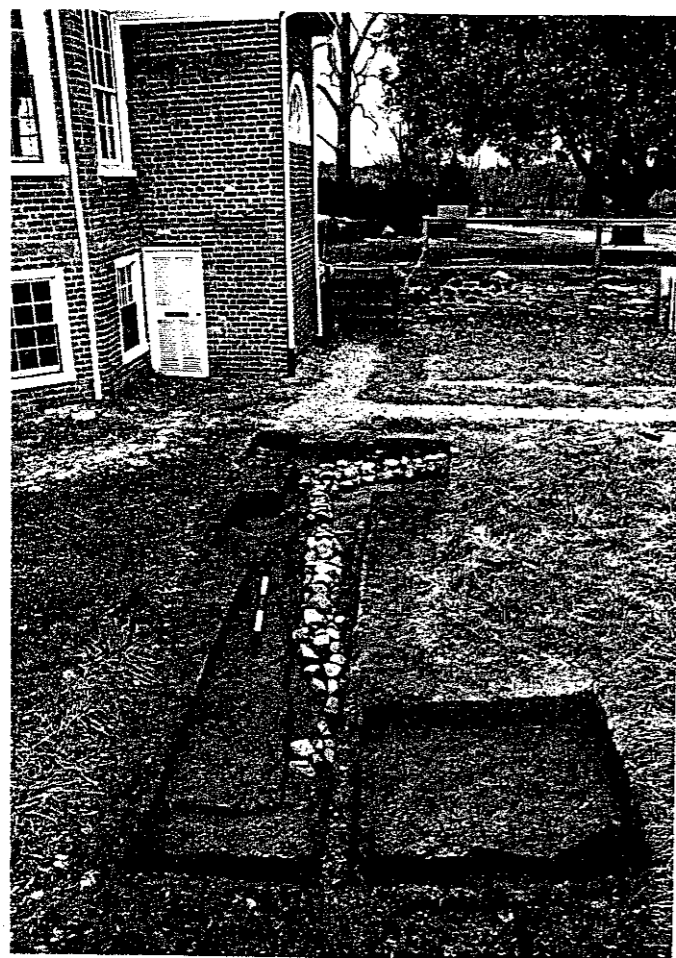
FIGURE 16

Excavated french drain with the house and the outline of the Wing of Offices marked in gravel in the background.

The drain showed no evidence of ever having connected with a line coming from the main house (Figure 16). Currently, there is no archaeological evidence of how the roof was drained. Interestingly, the french drain ended abruptly in a modern utility disturbance. Although a large area beyond the utility line was excavated, no evidence that the drain had ever continued in this direction was discovered. Similarly, no evidence of a cistern or similar receptacle for the waste water exists. Apparently, the water was conducted a reasonable distance from the wing, and discharged into the south lawn.
