35 PRESERVATION BRIEFS

Understanding Old Buildings: The Process of Architectural Investigation

Travis C. McDonald, Jr.

U.S. Department of the Interior
National Park Service
Cultural Resources
Heritage Preservation Services

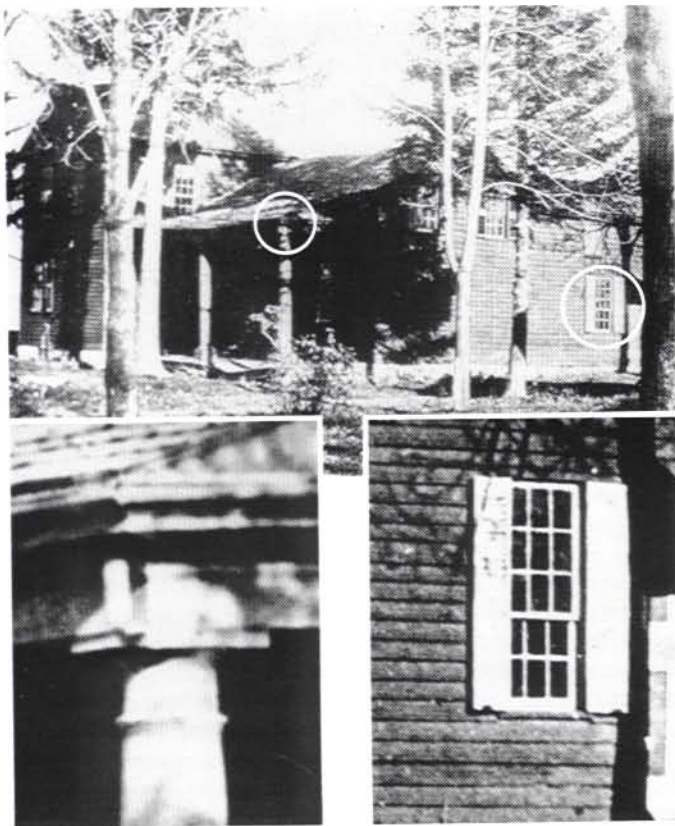
Figure 2. Early photographs discovered during historical research can be enhanced through photo-micrography to accurately recreate missing elements and details during restoration. The enlargements helped clarify questions about the porch column detail and the type of shutter hardware. photo: E. C. Stanton House, courtesy Seneca Falls Historical Society, New York; insets: NPS North Atlantic Cultural Resource Center, Building Conservation Branch.

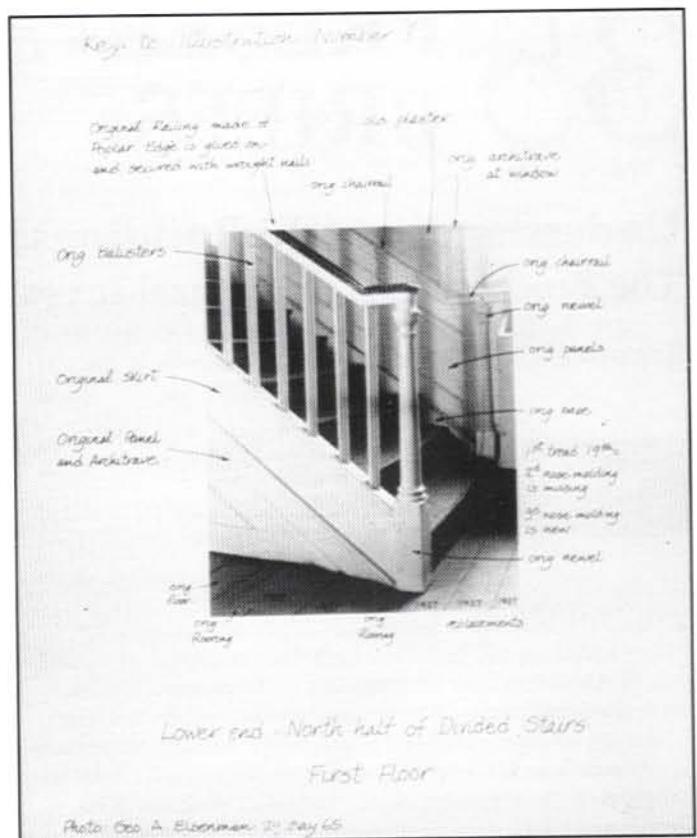
Figure 3. Dating, labeling, and providing annotated photographs is a simple, yet effective, way to document today's preservation efforts for future work and research. A useful document can be created by mounting a photograph upon archival paper and writing the annotations by hand. photo: NPS Preservation Assistance Division Files.

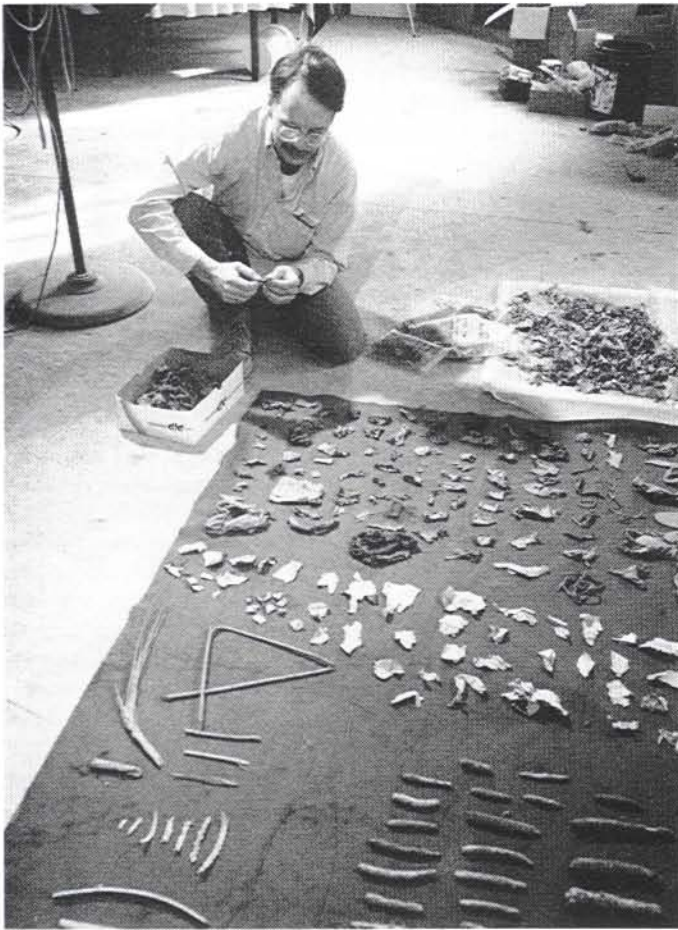
Figure 4. An inventory of animal nests found within hidden spaces of a structure may yield unexpected evidence, such as information about food, decorative arts, and cultural or social traditions of every day life. Typical items of paper, fabric and wood are important artifacts which are generally not found during archeology digs in the ground. photo: Tom Graves, Jr., courtesy Jefferson's Poplar Forest.

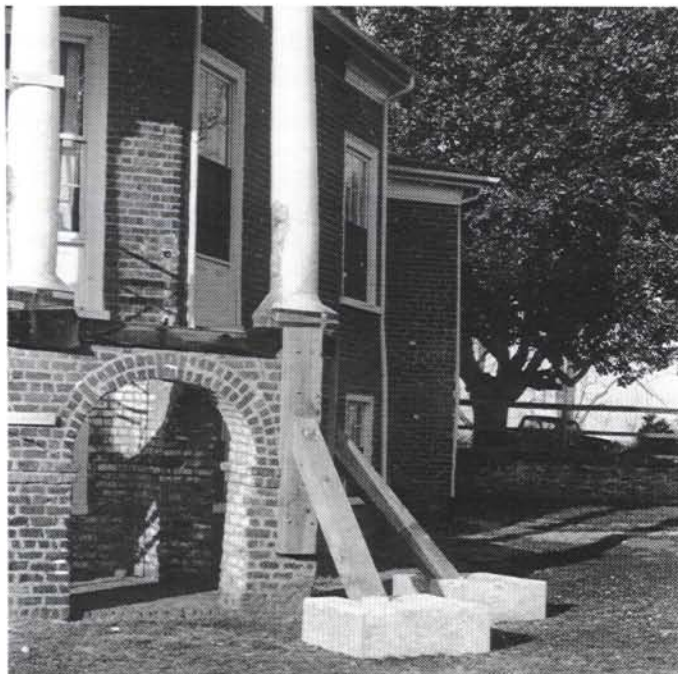
Figure 5. Investigation frequently identifies urgent needs of stabilization. Priority must be given to issues of safety and structural integrity. Supplemental support, such as temporary shoring, may be required to prevent collapse and should be reviewed by a structural engineer.

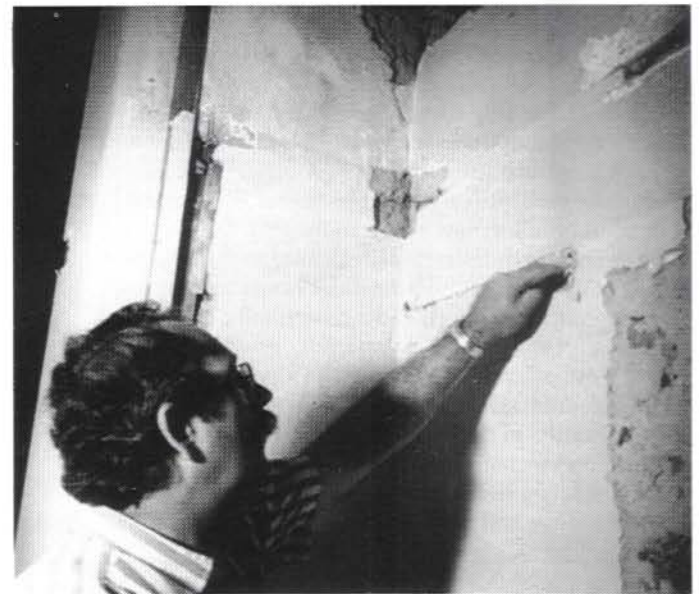
Figure 6. An investigator must have the skill and ability to closely observe and analyze the materials with a broad understanding of historic construction practices and technologies. Through the collection of samples and analysis of materials, investigative questions are either answered, refined, or formulated.

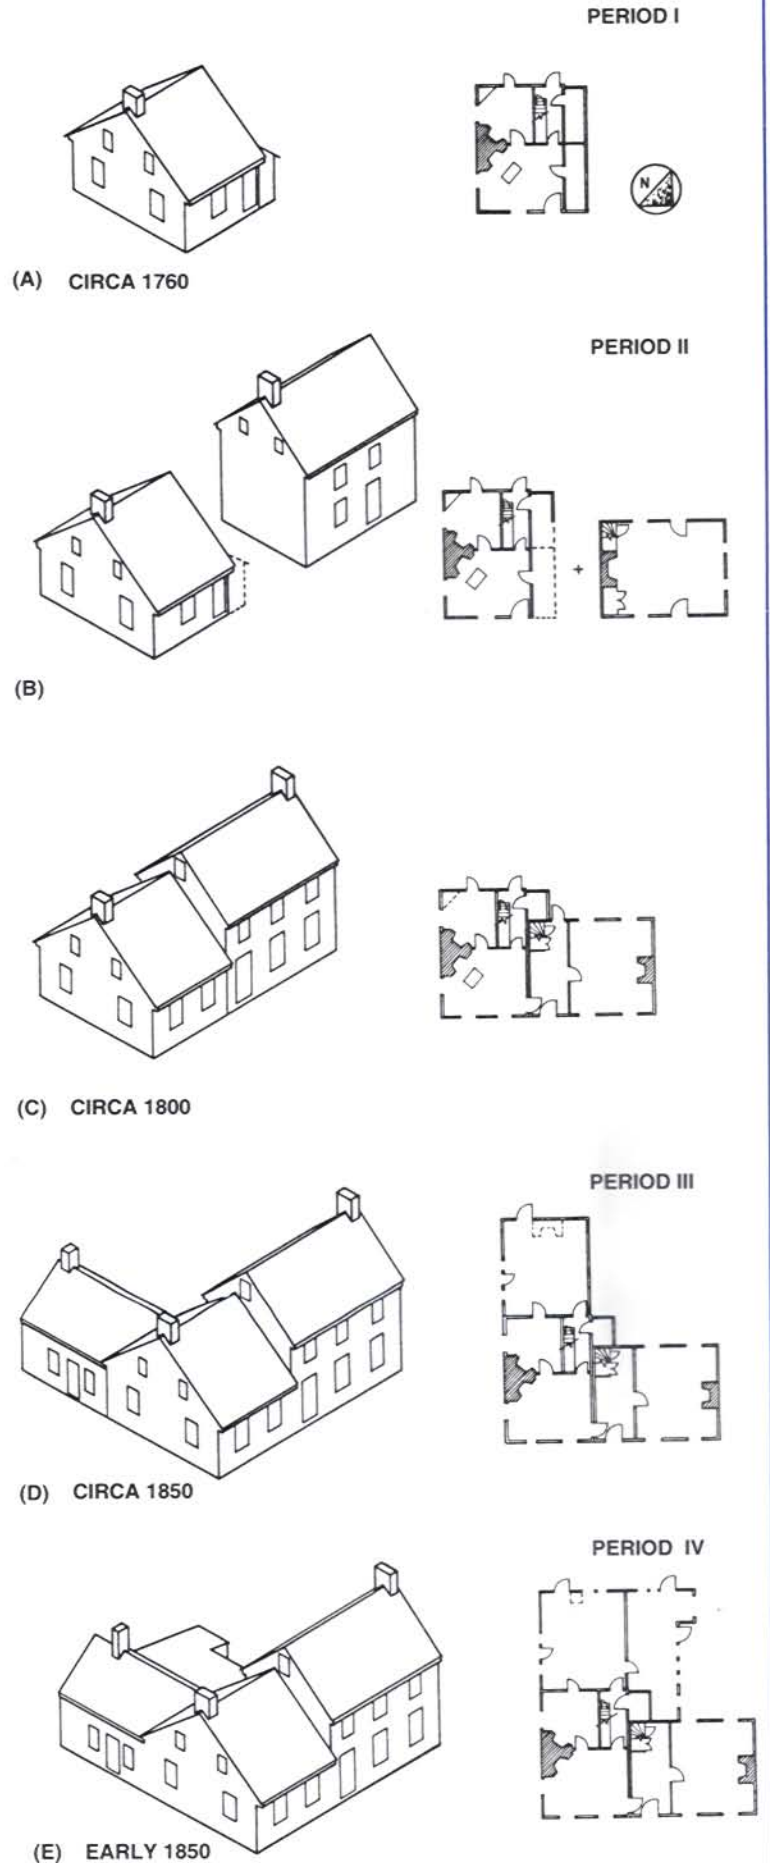
Showing the Evolution of an 18th Century Farmhouse

The example of a Sussex County, Delaware, house—from ca. 1790 to the early 1900s—illustrates how complicated the pattern of change over time can become in outlining an individual house history. The Hunter Farm House was built in the 18th century as a double-cell, double-pile, half-passage plan (a). Two bays across the front and two stories tall, the house possessed back-to-back corner fireplaces with fully paneled fireplace walls in the front and back rooms. A stair in the rear passage provided access to the second floor. A one-story, two-room shed that was attached to the gable wall farthest from the fireplace was accessed by a low door leading from the front room.

During the course of its history, the house was altered at least three times. The five-part illustration shows the house's transformation from an open plan to a Georgian plan and the subsequent addition and re-arrangement of service rooms for cooking and storage. The first remodeling occurred in the early nineteenth century when the lean-to shed was removed, and a two-story, single-pile, two-bay house was moved up and attached to the northwest gable of the existing building (b). (The newly attached building had originally been furnished with opposing doors and windows on the front and back facades, a fireplace on the southeast gable, and double windows on the opposite end.) When the second building was joined to the first, the fireplace in the newer building was relocated to the opposite gable; the front door in the older house moved to a more central position; and a center-hall plan created with a roughly symmetrical front elevation (c). A subsequent alteration later in the nineteenth century included the addition of a one-story rear service ell (d). Finally, in the early 1900s, the one-story service wing was increased. During this last remodeling, the large kitchen hearth was demolished and replaced with a stove and new brick flue (e).

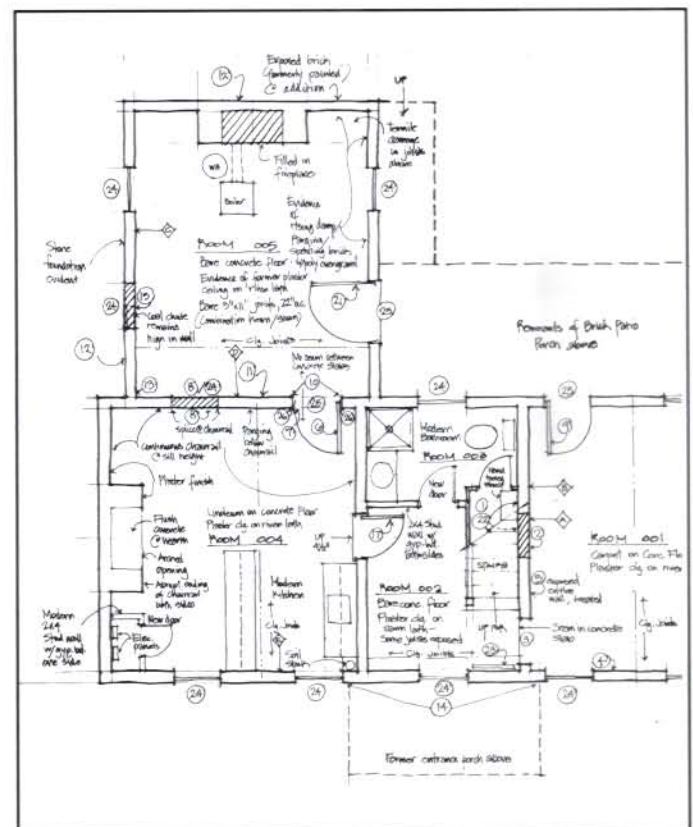
Figure 8. During the initial visit, the architectural investigator may be able to resolve many questions about the building's condition and chronology while recording their observations through field notes and annotated sketches. Drawing by Marianne Graham, courtesy Jefferson's Poplar Forest Restoration Field School.

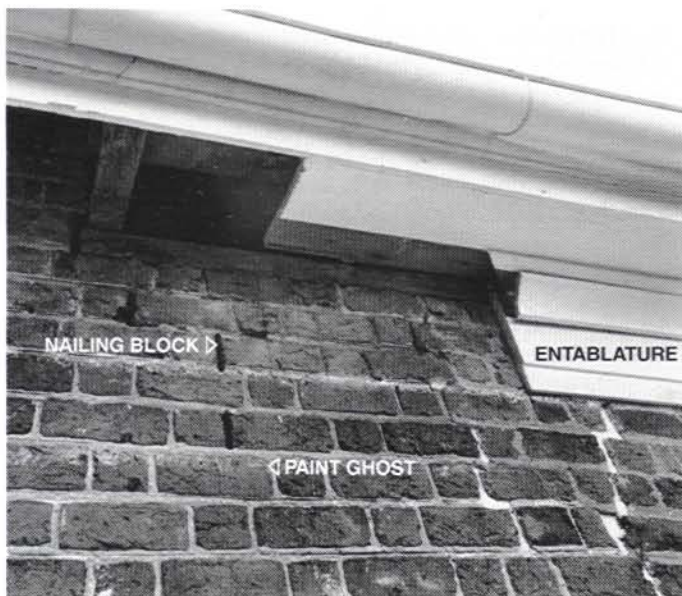
Figure A. Careful examination of the masonry reveals different periods of construction and repair through the composition and detailing of bricks and mortar. Depending upon location, open vertical joints may indicate the location of nailing blocks for decorative trim or weeps for drainage. These open joints at the building's cornice show evidence of an earlier wooden entablature extending down two courses below the present trim. The paint ghosts below the lowest blocks confirms the entablature's existence and provides clues to its size and finish.

Masonry. Studying historic brickwork can provide important information about methods of production and construction. For example, the color, size, shape and texture of brick reveals whether it was hand molded and traditionally fired in a clamp with hardwoods, or whether it was machine molded and fired in a kiln using modern fuels. Similarly, the principal component part of masonry mortar, the lime or cement, reveals whether it was produced in a traditional or modern manner. Certain questions need to be asked during investigation. Is the mortar made with a natural or a Portland cement? If a natural cement, did it come from an oyster shell or a limestone source? Is it hydrated or hydraulic? As a construction unit, brick and mortar further reveal something about the time, place and human variables of construction, such as the type of bond, special brick shapes, decorative uses of glazed or rubbed brick, coatings and finishes, and different joints, striking and tooling. Does the bond conform with neighboring or regional buildings of the same period? Does the pattern of "make up" bricks in a Flemish Bond indicate the number of different bricklayers? What is the method of attaching wood trim to the masonry? The same types of questions related to production and construction characteristics can be applied to all types of masonry work, including stone, concrete, terra cotta, adobe and coquina construction. A complete survey undertaken during "surface mapping" can outline the materials and construction practices for the

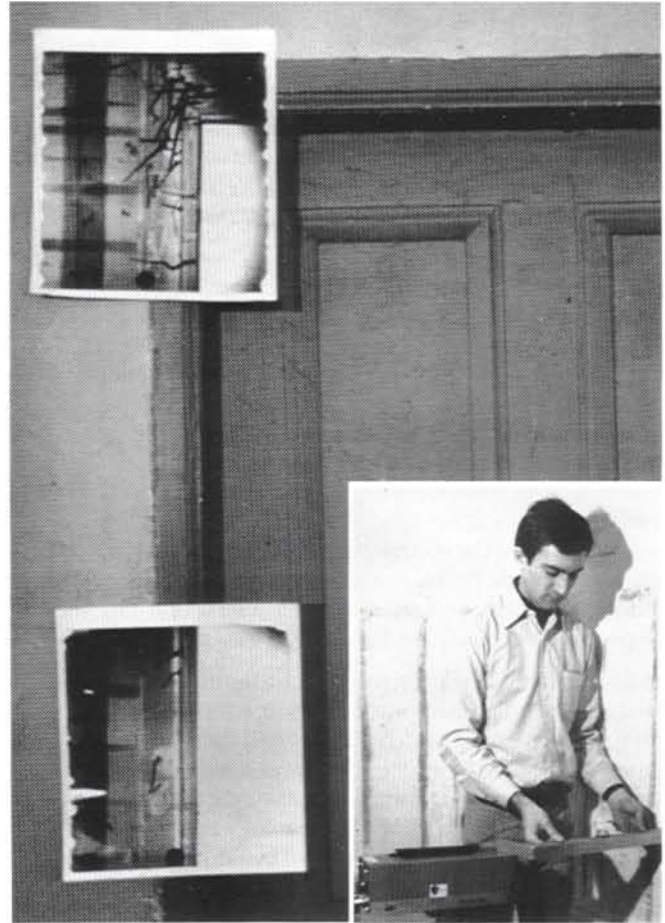
Figure B. Without damaging or altering historic fabric, X-ray images of wood connections provide internal views of construction materials and techniques. These x-ray images show nails being used to form the connections of a door opening in a wood stud wall covered with plaster and cut wooden lath. A single technician can operate the portable equipment and develop the film on site for immediate analysis. photos: NPS North Atlantic Cultural Resource Center, Building Conservation Branch.

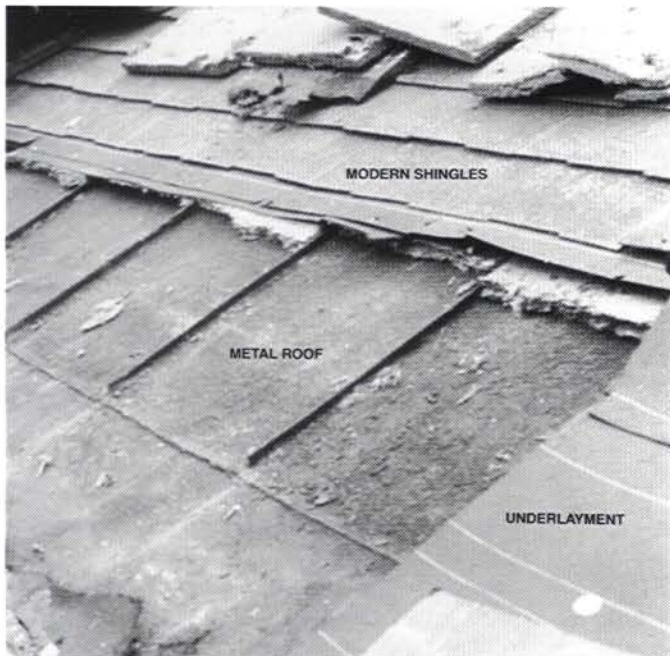
Figure C. In many cases, new materials or coverings are placed directly over existing exterior features, preserving the original materials underneath. Here, the removal of a modern shingle roof and its underlayment revealed an historic standing seam metal roof. photo: courtesy, Phillips and Opperman, P.A.

Roofs. Exterior features are especially prone to alteration due to weathering and lack of maintenance. Even in the best preserved structures, the exterior often consists of replaced or repaired roofing parts. Roof coverings typically last no more than fifty years. Are several generations of roof coverings still in place? Can the layers be identified? If earlier coverings were removed, the sheathing boards frequently provide clues to the type of covering as well as missing roof features. Dormers, cupolas, finials, cresting, weathervanes, gutters, lightning rods, skylights, balustrades, parapets and platforms come and go as taste, function and maintenance dictate. The roof pitch itself can be a clue to stylistic dating and is unlikely to change unless the entire roof has been rebuilt. Chimneys might hold clues to original roof pitch, flashings, and roof feature attachments. Is it possible to look down a chimney and count the number of flues? This practice has occasionally turned up a missing fireplace. In many parts of the country, nineteenth-century roof coverings evolved from wooden shingles or slate shingles, to metal shingles, to sheet metal, and still later in the twentieth century, to asphaltic or asbestos shingles. Clay tiles can be found covering roofs in seventeenth and eighteenth-century settlements of the east coast as well as western and southwestern Spanish settlements from the same period. Beyond the mid-nineteenth century, and into the twentieth, the range and choice of roof coverings greatly expanded.

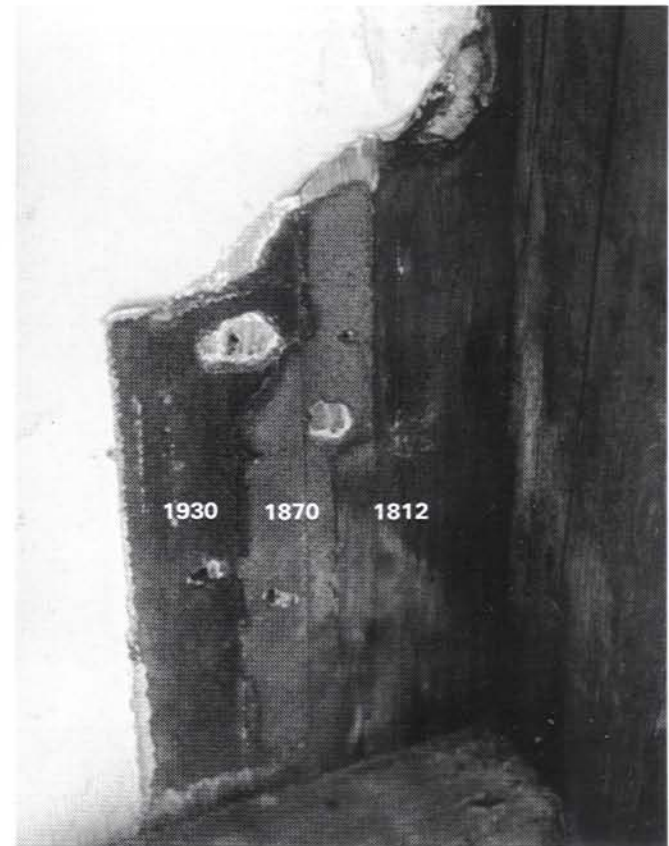
Figure D. Building styles change over time as moldings and trims are added and removed. The ghosts of the previous woodwork are often left behind and preserved under the new trim. This photograph shows distinct profiles of architectural trim from three successive periods. photo: courtesy, Valentine Museum, Richmond, Virginia.

Walls. Walls and their associated trim, both outside and inside, hold many clues to the building's construction and changes made over time. The overall style of moldings, trim and finishes, and their hierarchical relationship, can help explain original construction as well as room usage and social interaction between rooms. Holes, scars, patches, nails, nail holes, screws and other hardware indicate former attachments. Are there "ghosts," or shadow outlines of missing features, or trim attachments such as bases, chair rails, door and window casings, entablatures, cornices, mantels and shelves? Ghosts can be formed by paint, plaster, stucco, wear, weathering or dirt. Interior walls from the eighteenth and early nineteenth-century were traditionally plastered after grounds or finished trim was in place, leaving an absence of plaster on the wall behind them. Evidence of attachments on window casings can also be helpful in understanding certain interior changes. Other clues to look for include

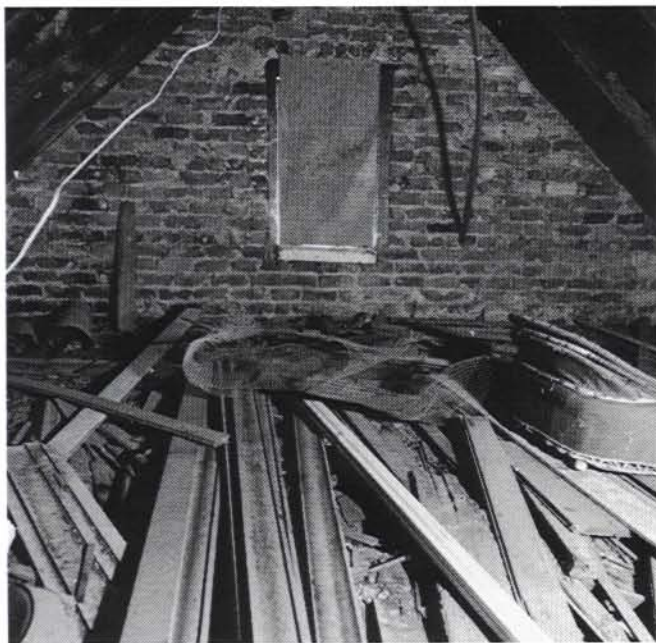
Figure E. Discarded items are routinely stored within attics, then forgotten, only to be discovered during a later investigation. Seemingly worthless clutter and debris may help answer many questions. A thorough inventory should be performed before evaluating any object's usefulness.

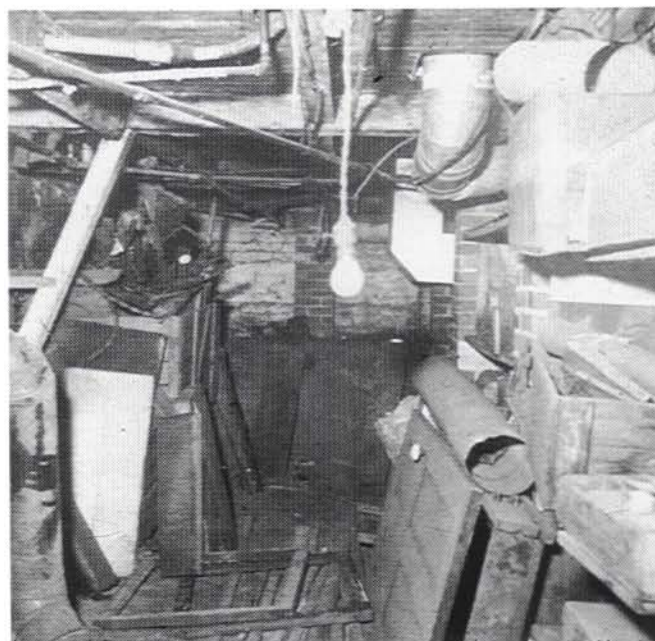
Figure F. Outdated fixtures and systems are frequently abandoned in place when more modern units are installed. Examining and documenting their existence can provide a technological reference to the history and use of many rooms or structures. photo: NPS Preservation Assistance Division Files.

Mechanical, Electrical, Plumbing and Other Systems. Systems of utility and convenience bear close scrutiny during investigation. All historic buildings inhabited and used by people reveal some association, at the very minimum, with the necessities of lighting, climate control, water, food preparation, and waste removal. Later installations in a building may include communication, hygiene, food storage, security, and lightning protection systems. Other systems, such as transportation, are related to more specific functions of commercial or public structures. Although research into the social uses of rooms and their furnishings has borne many new studies, parallel research into how people actually carried out the most mundane tasks of everyday life has been fairly neglected. Utility and convenience systems are most prone to alteration and upgrading and, at the same time, less apt to be preserved, documented or re-used. Understanding the history or use of a building, and the history of systems technology can help predict the physical evidence that might be found, and what it will look like after it *is* found.

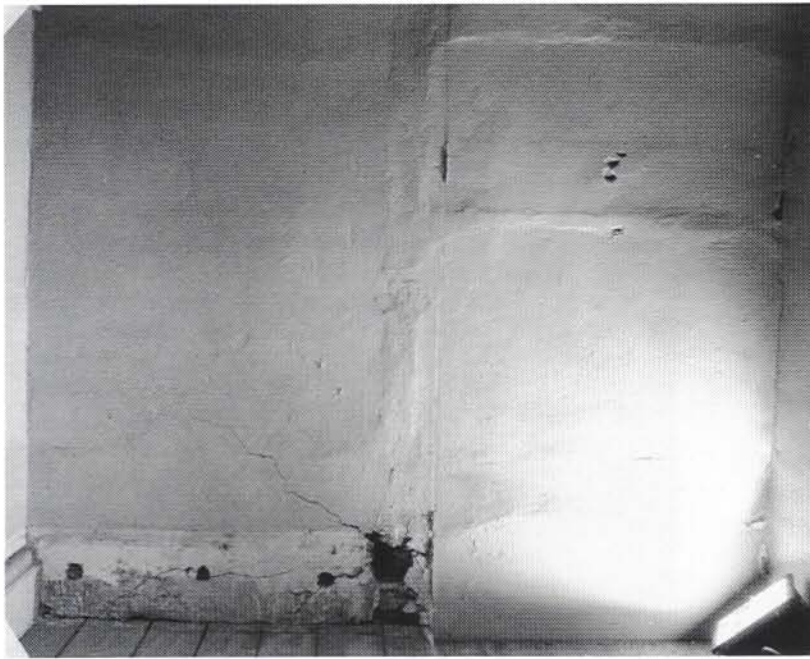
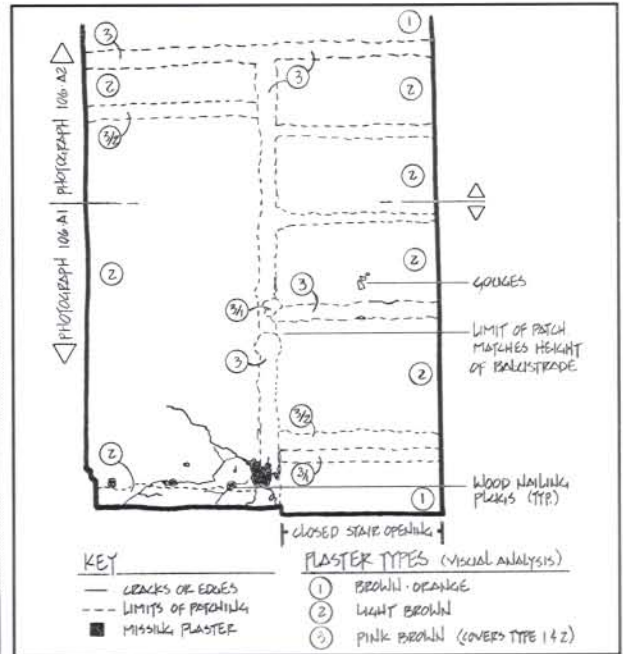
Figure 9. Raking light is used to show irregularities on flat surfaces. Patches, repairs, and alterations can then be mapped by the shadows or ghosts they cast. In this case, the pattern of patched plaster suggested the removal shelves and a balustrade handrail from the wall. Historical research and plaster analysis confirmed the findings and the sequence of change.

While relying upon senses of sight and touch, the most useful tool for examining surfaces is a high-powered, portable light used for illuminating dark spaces as well as for enhancing surface subtleties. Raking light at an angle on a flat surface is one of the most effective means of seeing evidence of attachments, repairs or alterations.

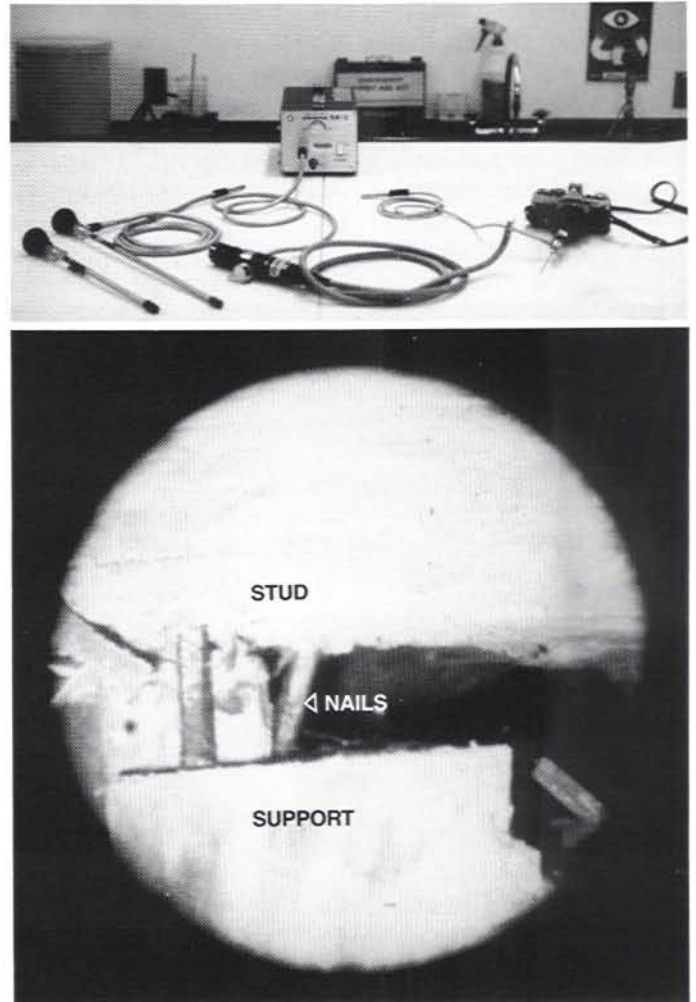
Figure 10. Top: A boroscope is a fiber-optic tube which can provide views into the framing connections of a wall through an existing crack or hole. Bottom: Once the image is oriented, the investigator can see an open joint between the wood stud and its nailed lateral support. photos: NPS North Atlantic Cultural Resource Center, Building Conservation Branch.

technology combines the boroscope with video cameras using fiber optic illumination. In addition to the more common use of infra-red photography, similar non-destructive techniques used in archeological investigations include remote sensing and ground-penetrating radar.

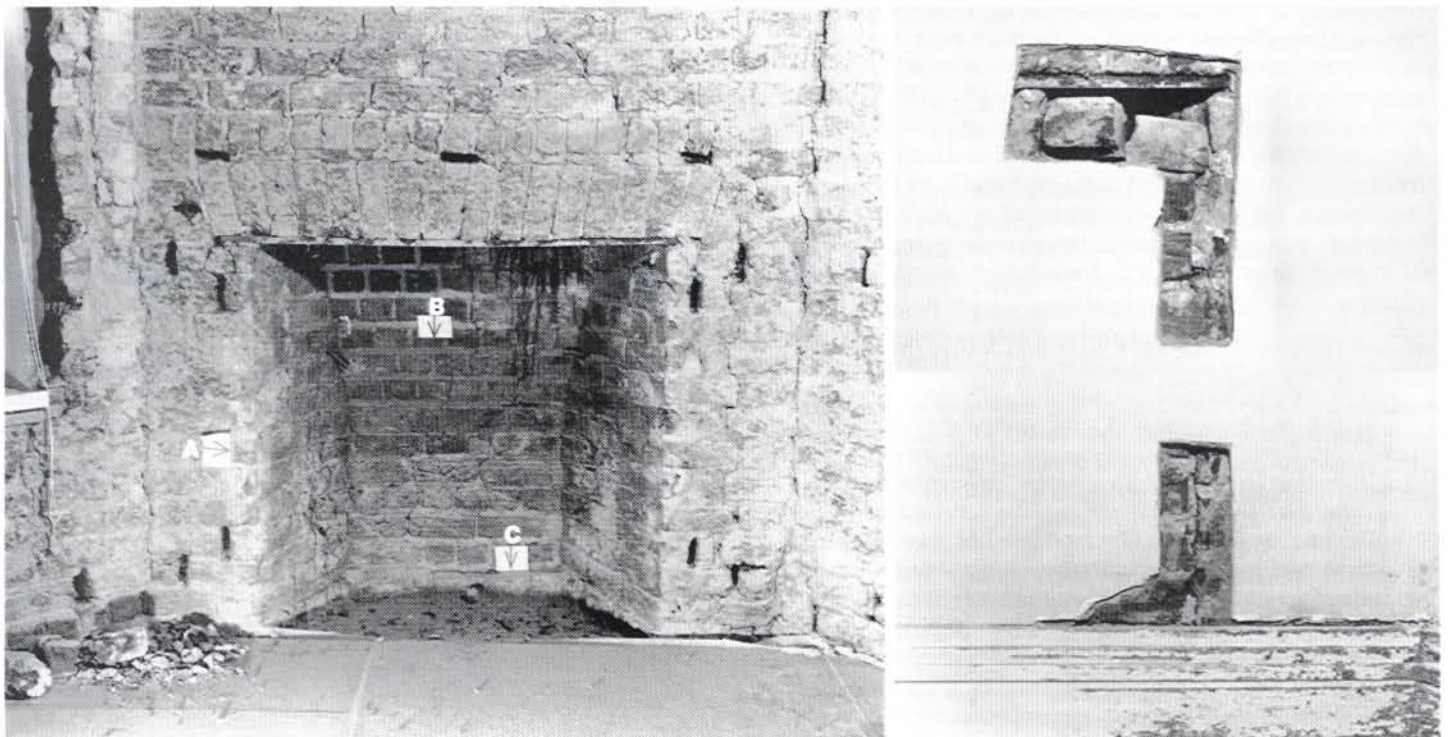
Figure 11. The physical evidence of cracks and patches seen during surface mapping suggested an abandoned fireplace. Right: Exploratory testing was used to verify its location. Left: Museum restoration required more detailed probing to discover the original detailing. Plaster and brick were carefully documented and removed to determine the fireplace's type, size, and decoration. The rectangular slots held wooden nailing blocks supporting the mantel and surround. A indicates the inside edge of the surround; B points to the ghost from an iron fireback and C shows the original floor level of the hearth.

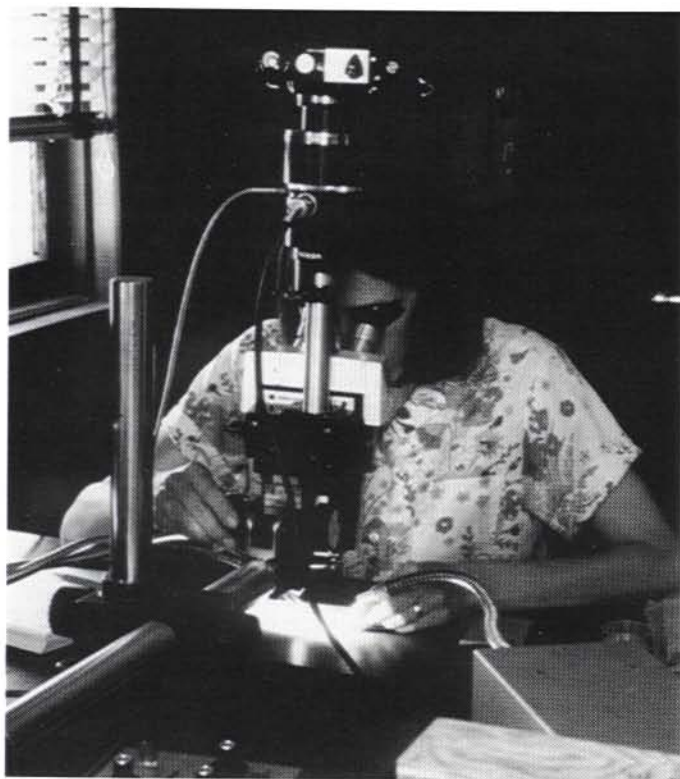
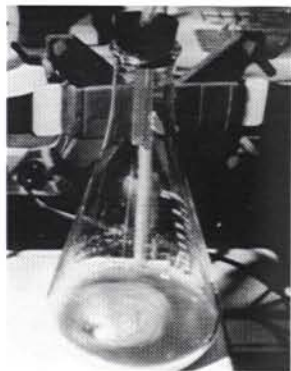
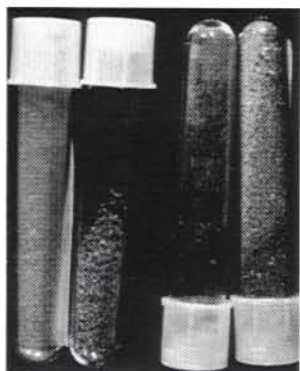
Figure 12. During a thorough investigation, the mortar sample is viewed under a microscope using various lighting to find the presence of coatings or additives. It is then ground and washed in an acid bath to separate and free the sand and fibers. After further cleaning, these fines are stored and used for comparison in matching or dating repairs and alterations. photos: NPS North Atlantic Cultural Resource Center, Building Conservation Branch.

Mortar and plaster analysis often provide a basis for dating construction with minimal intervention. Relatively small samples of the lime-based materials can be chemically separated into their component parts of sands and fines, which are then visually compared to equivalent parts of known or dated samples. A more thorough scientific approach may be used to accurately profile and compare samples of other materials through elemental analysis. Two similar methods in common use are Neutron Activation and Energy Dispersive Spectroscopy (EDS). Neutron Activation identifies the sample's trace elements by monitoring their response to neutron bombardment. EDS measures the response to electron bombardment through

the use of an electron microscope. In both tests, the gathered information is plotted and matched with the reactions of known elements. The results provide a quantitative and qualitative profile of the sample's elemental components for use in further comparisons.
